# YOUR ONESURVEY HOME REPORT

Castlerock  
Glenelg, Kyle  
IV40 8JZ

# SINGLE SURVEY

***Alder Specialist Building Surveyors Ltd***

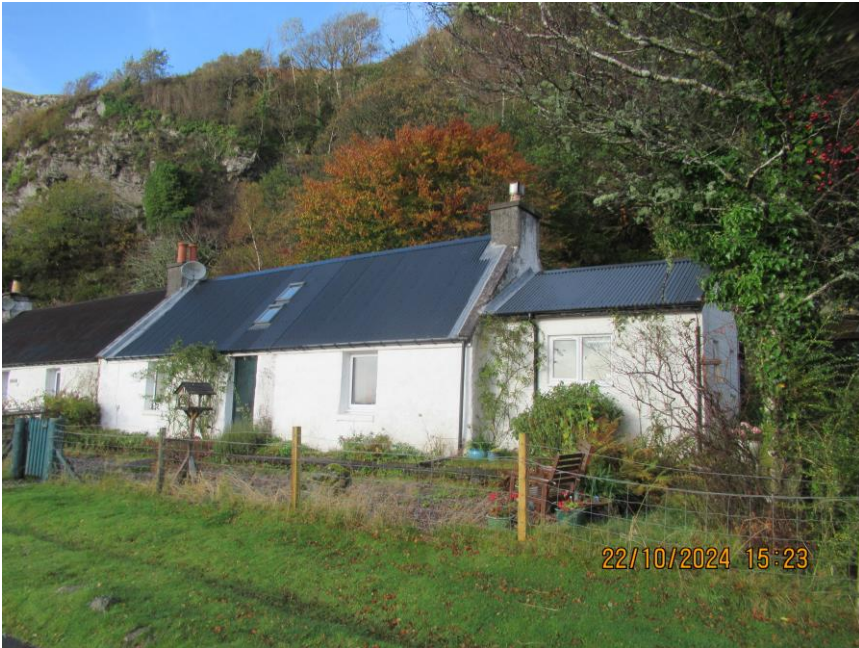
*The cottage sits at the bottom of a rock face. The water that comes off the rock face creates extremely high ground moisture levels next to the lower rear and right-hand gable walls. This moisture has found its way into the lower external walls and solum as demonstrated later in this report.*

*My understanding is that the profile roof clad has been renewed in the recent past.*

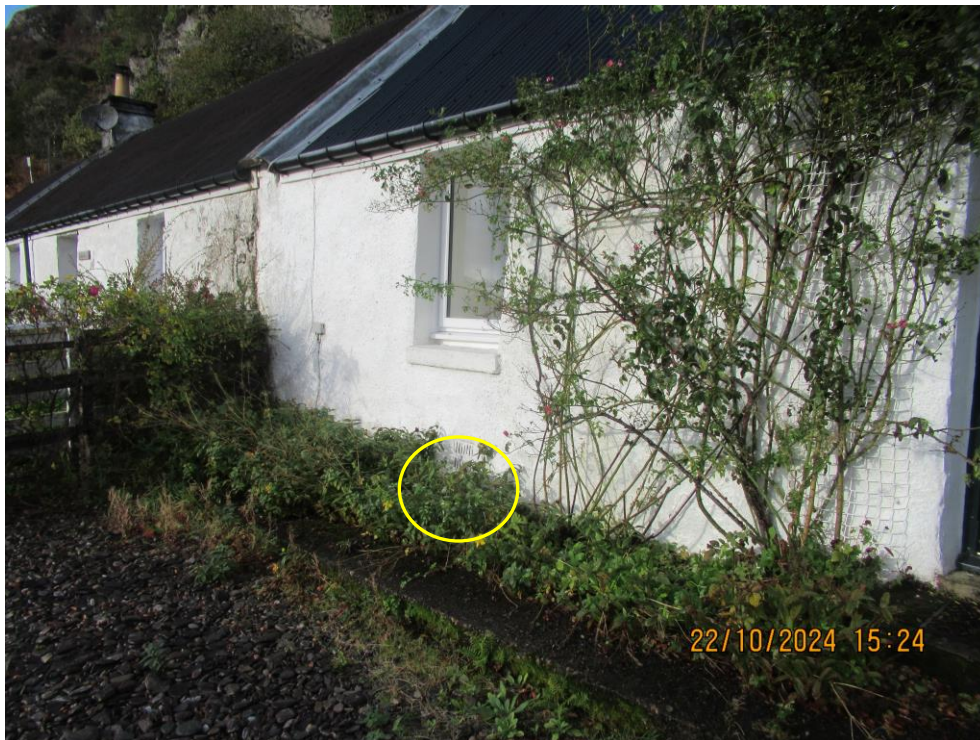
*Limited sub-floor ventilation on the left-hand side of the front wall (Bedroom No.1 area).*

*Vegetation growth right next to the outer walls.*

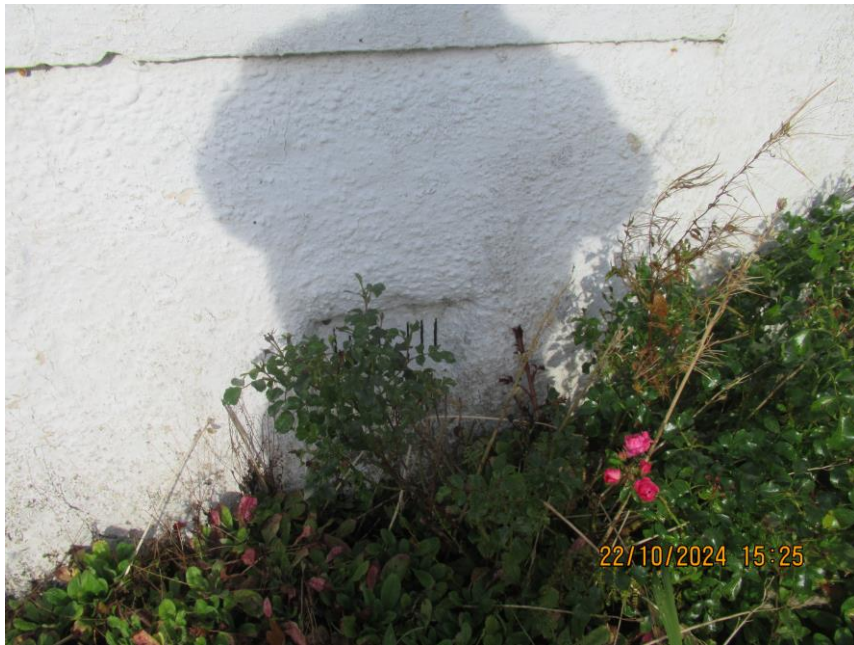
*Limited sub-floor ventilation on the right-hand side (Lounge area), where the only vent in place have been painted over. Vegetation is in direct contact with the lower wall.*

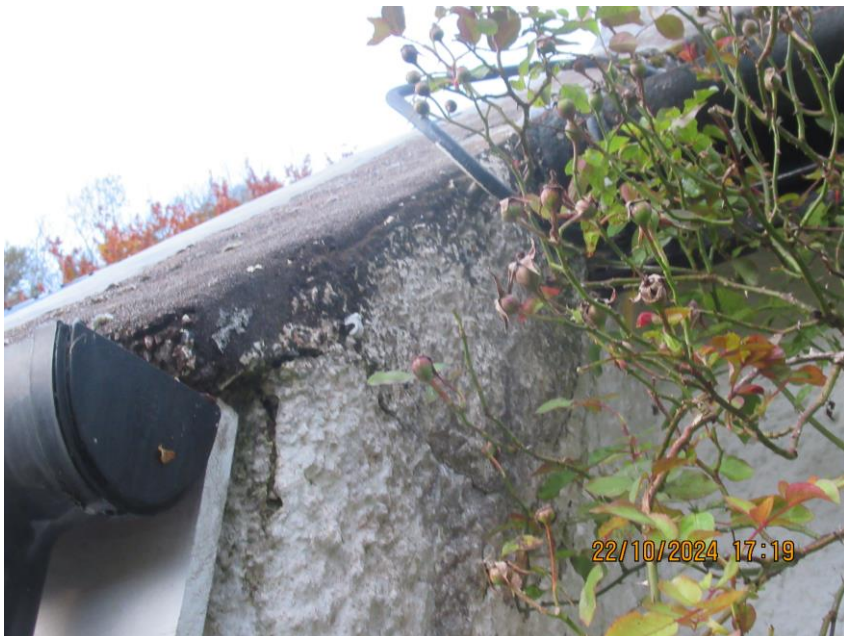
*This is the front wall/gable where the extension is attached.*

*There is defective rendering at this corner and a poor gutter detail, both of will allow potential water ingress.*

**Note:** *there is an area of high damp readings in the kitchen wall that partitions the kitchen from the lounge and in front of the fridge which will be highlighted later in this report. This photo may possibly be a contributing factor for this damp.*

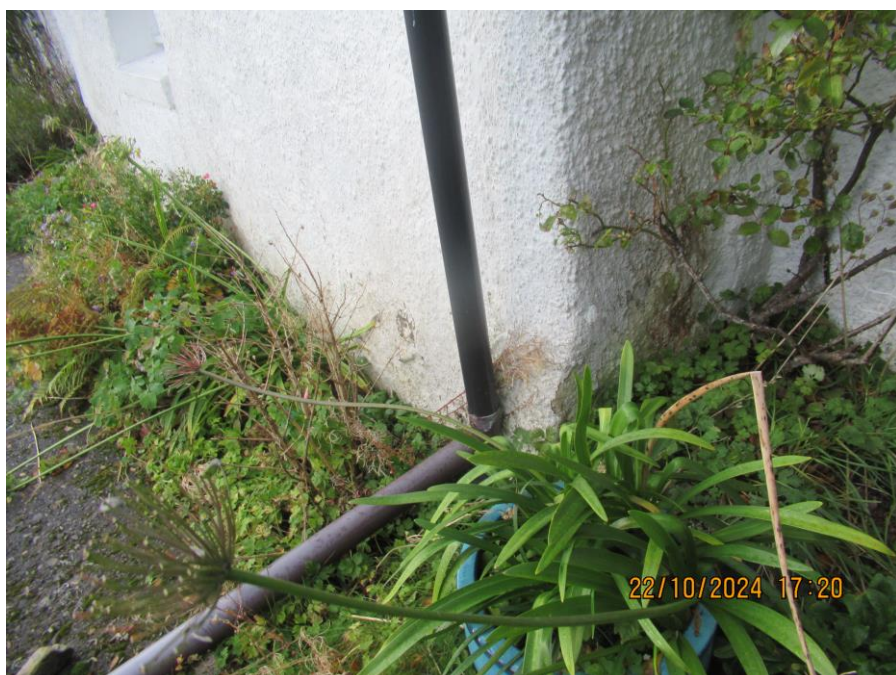
*This photo is directly below the above photo. The ground levels are slightly high, and you will note the dampness in the lower render.*

*The rain water downpipe has been extended across the pavement and discharges on the ground as apposed to into under ground drainage.*

*This may also be a contributing factor to the damp in the kitchen mentioned later in this report.*

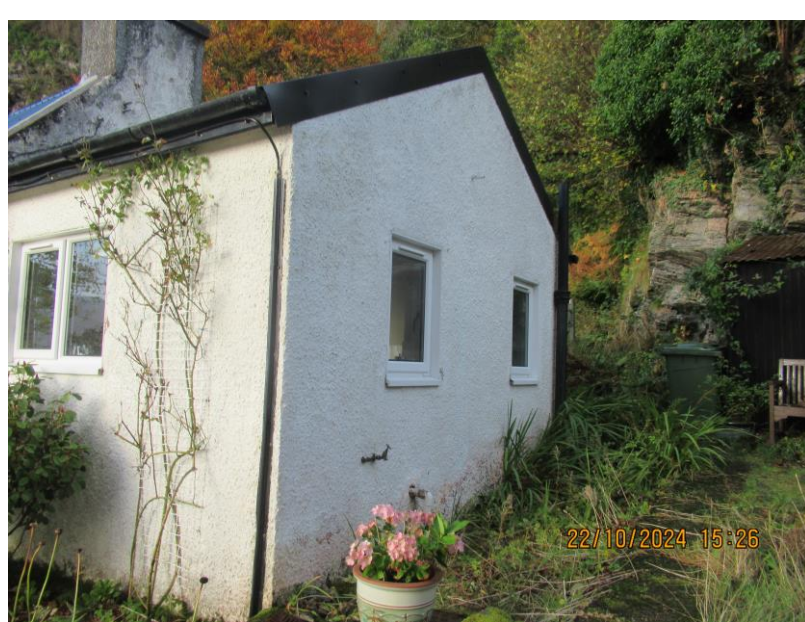
*High ground levels against the extension gable that increase in height the further back towards the rear wall.*

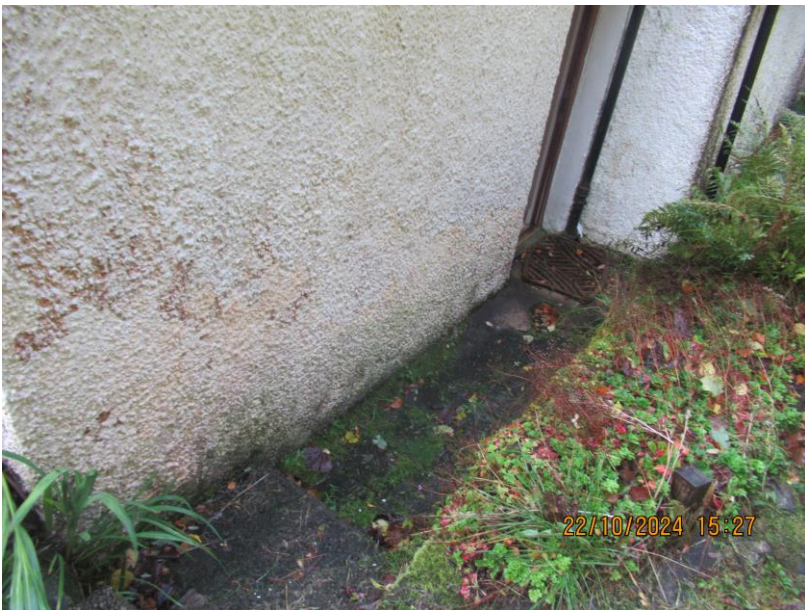
*This is the rear wall of the extension outside of the shower room. There is a retaining wall approximately 750mm back from the cottage wall. Between the walls, the ground is overlaid with slabs that are hard up to the cottage.*

*There is no form of drainage, and you will note the damp and vegetation growth on the lower cottage wall. The ground level here is equal to the internal solid floor level, where the external ground level should be at least 150mm below the internal floor levels.*

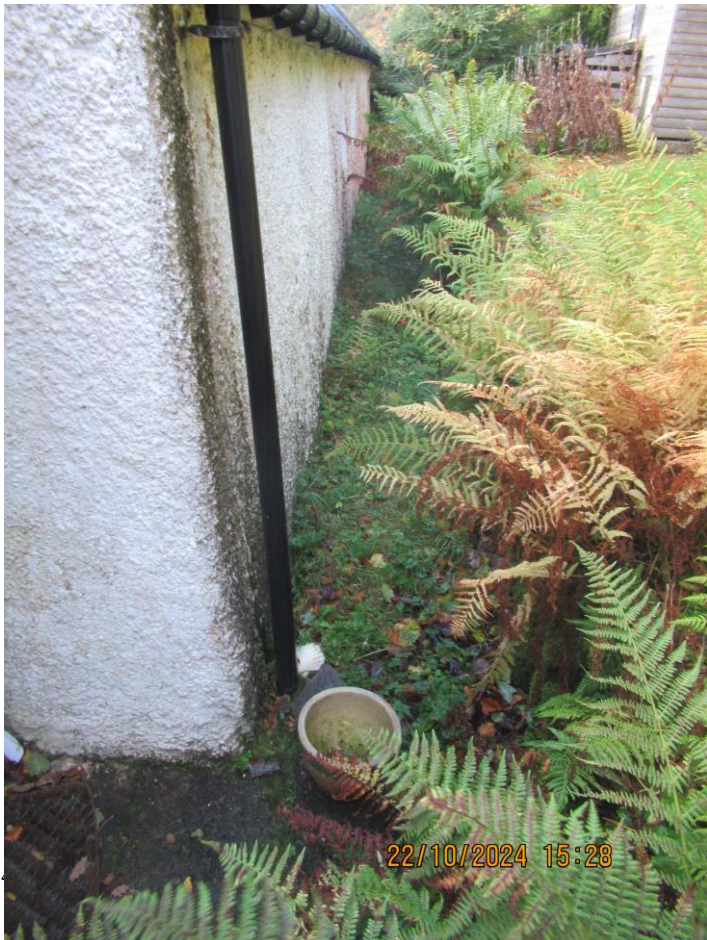
*Further along the rear wall behind the original cottage, the ground levels are high in between the cottage wall and the earth retaining wall. There is a single down pipe, and I do not anticipate there to be appropriate land or rain water drainage based on what I have seen.*

*Note the algae trail on the wall starting at the top of the down pipe.*

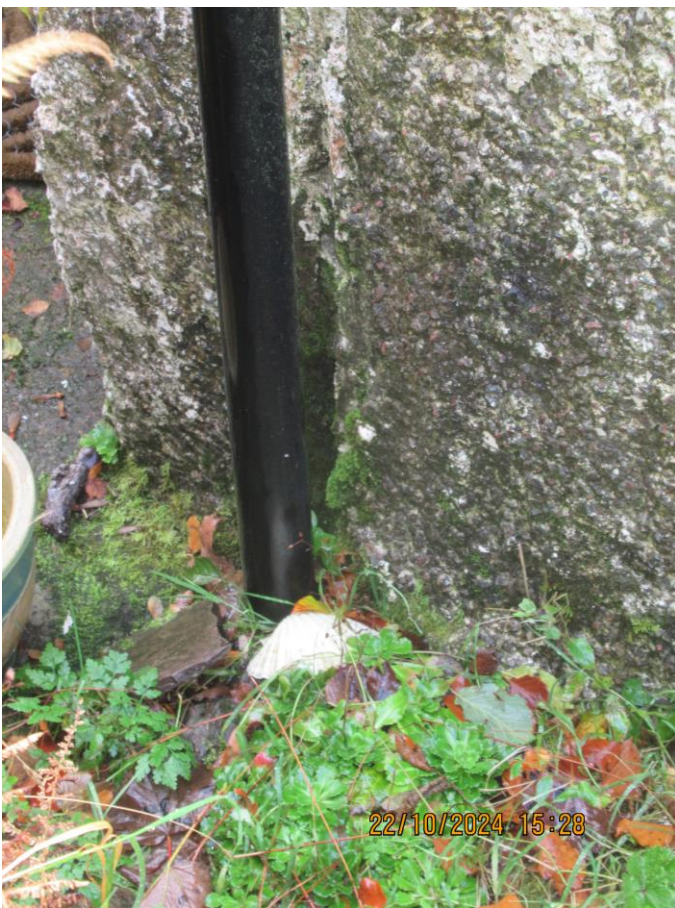
*A closer look at the bottom of the down pipes confirms the above points made and assumed. The render is also defective on this lower section of the wall.*

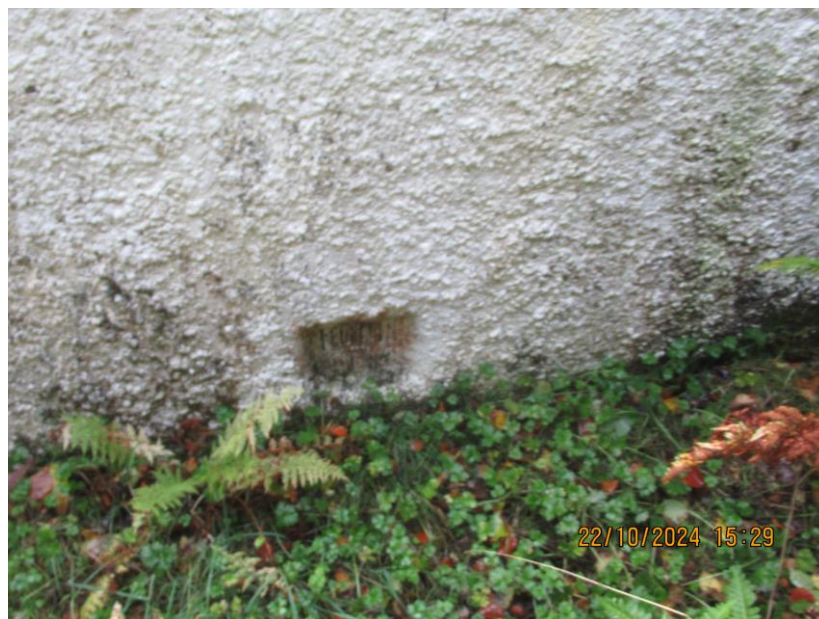
*Further along the rear wall, ground levels continue to be high and the lower render wet. The sub-floor vent of the lounge is partially blocked and painted over.*

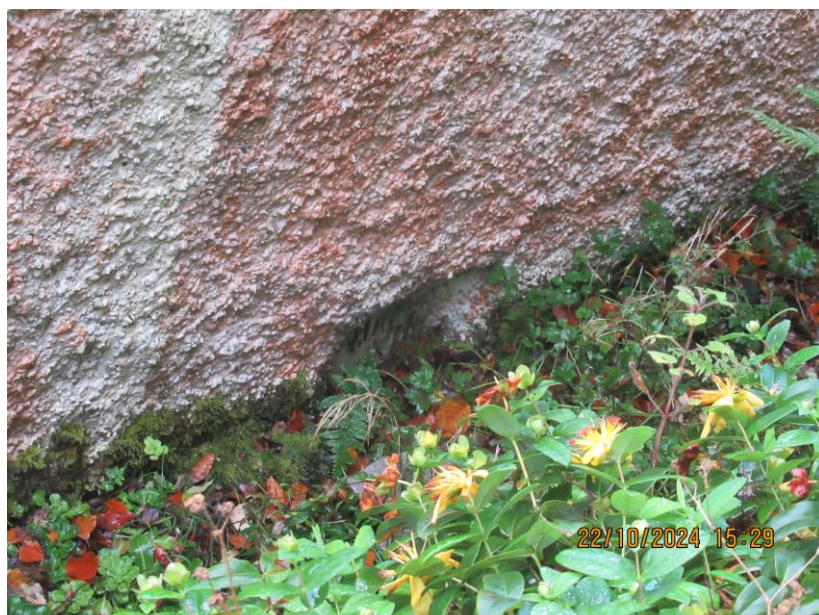
*Further along the rear wall to the point of just outside of Bedroom No 1, shows the ground levels continue to rise and sub-floor vent blocked.*

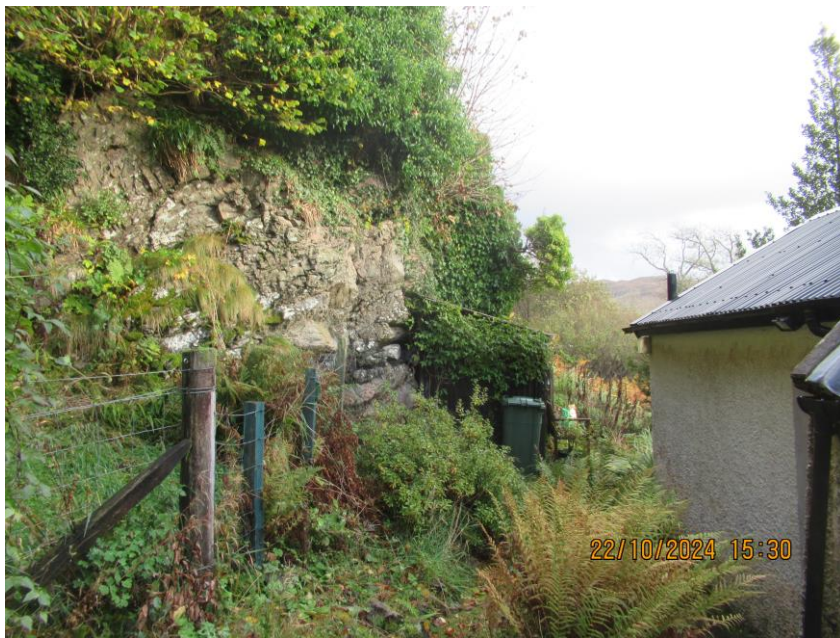
*This photo show the close proximity of the rock face behind the cottage. As stated, the water coming off the face will create extreme hydrostatic pressure in the ground and forcing the ground water towards the cottage and whilst there is a small earth retaining wall approximately 750mm back from the cottage walls, I am of the opinion that appropriate and additional land drainage will be required. This can be verified by an engineer.*

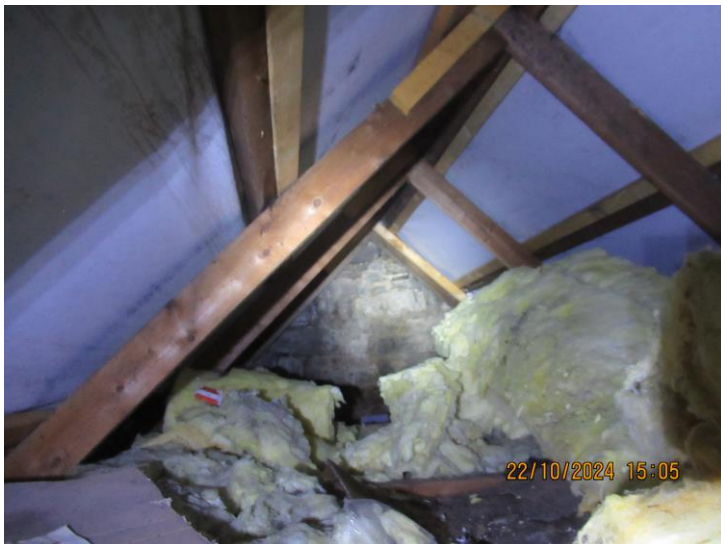
*The roof timbers have been patched and repaired in the recent past.*

*There is glasswool within the loft, however, it is scattered are requires re-setting.*

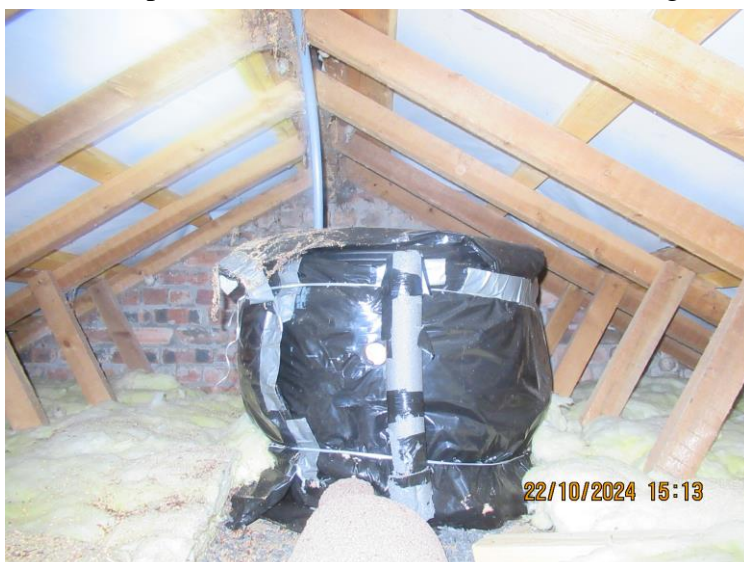
*The roof timbers are of a newer construction.*

*Insulation materials are properly placed in this void.*

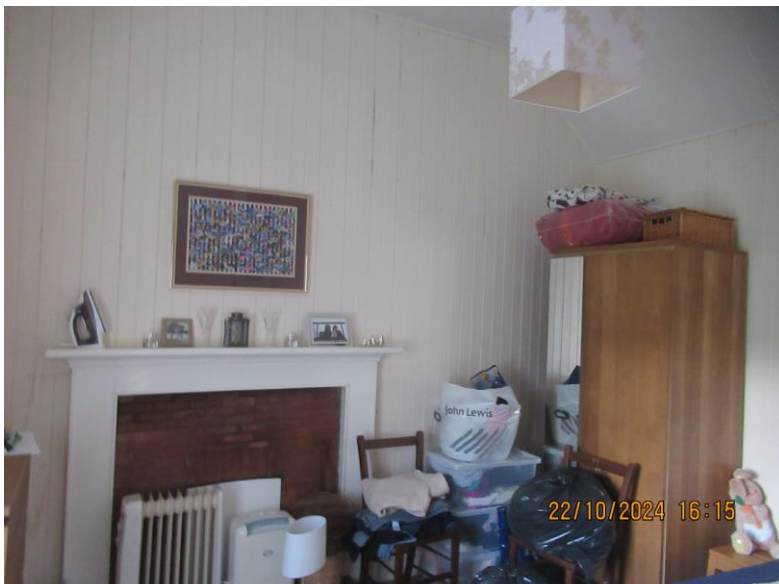
*This photo demonstrates the amount of furniture and stored items in this room, and I can confirm that all the rooms at this level have the same about of stored items and furniture and fitted floor coverings that severely restricted my inspections.*

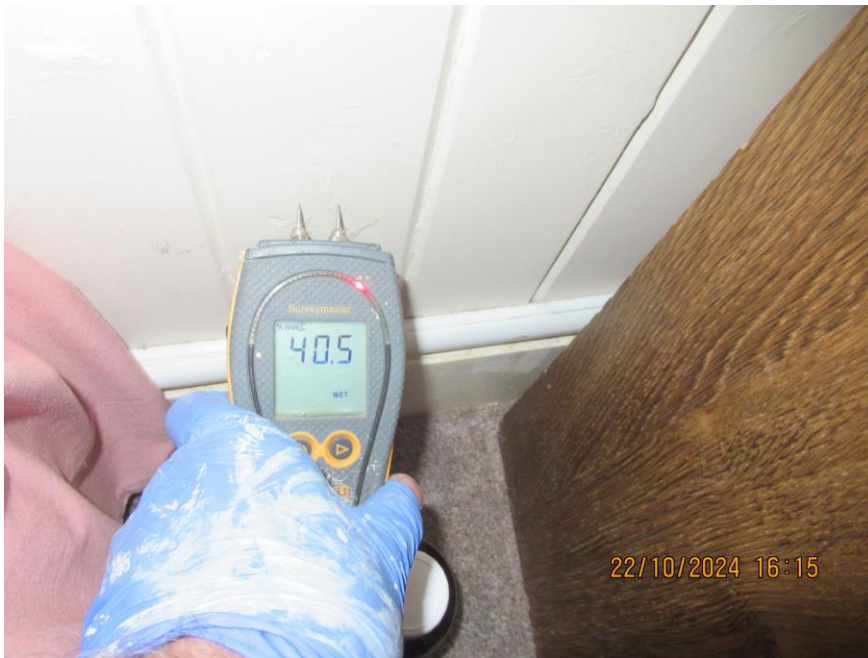
*M/C (Surface Moisture Content, as per the above chart), at 40.5% recorded from the rear right-hand lower wall corner of this room has registered as high.*

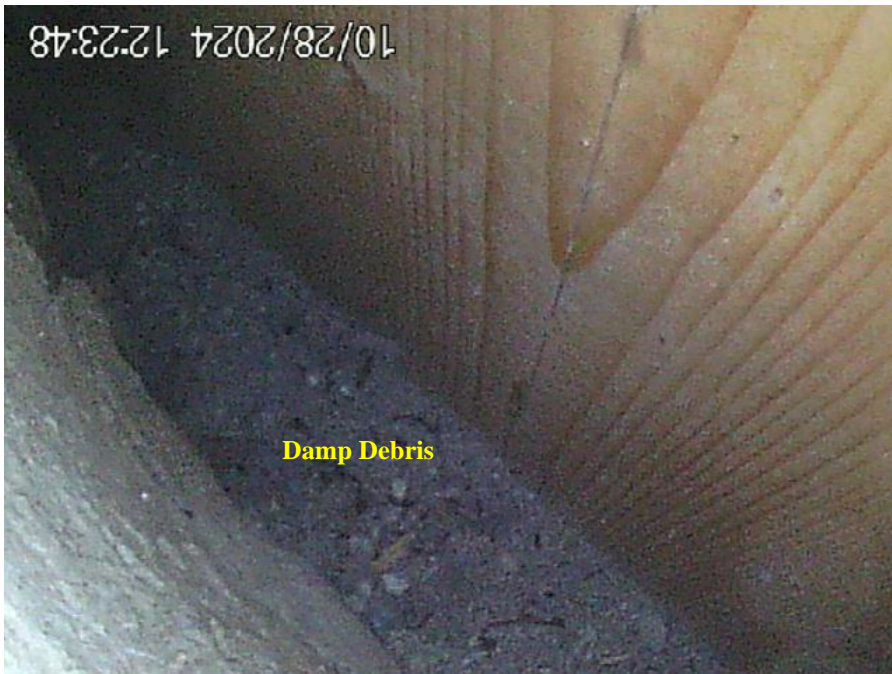
*This Fibre-Optic photo taken in behind the area of the above photo, shows (also indicated on the sketch above), the painted masonry wall on the left and the bottom of the lining timbers on the right. There is a slight damp “tide line mark” at the bottom of the timber linings. This is a result of the debris (between the damp external wall and the linings seen in the middle of the photo), bridging the damp from the masonry to the lining boards.*

*This is consistent in all areas where the lower walls were inspected with Fibre-Optics*

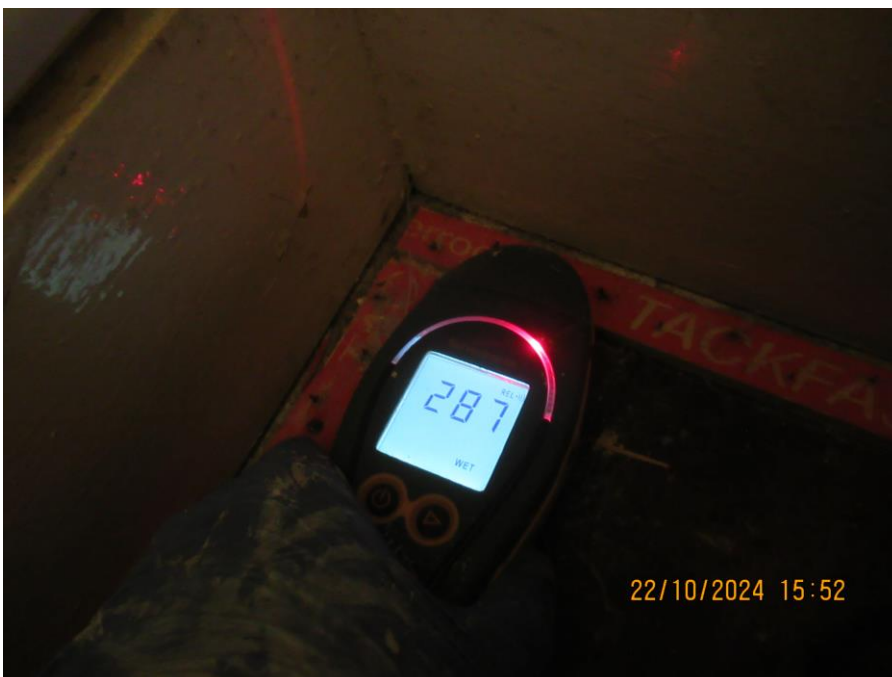
*This photo is the surface of the floorboards and was taken just below the location of the above photos.*

*M/C (Surface Moisture Content, as per the above chart), at 28.7% is slightly high.*

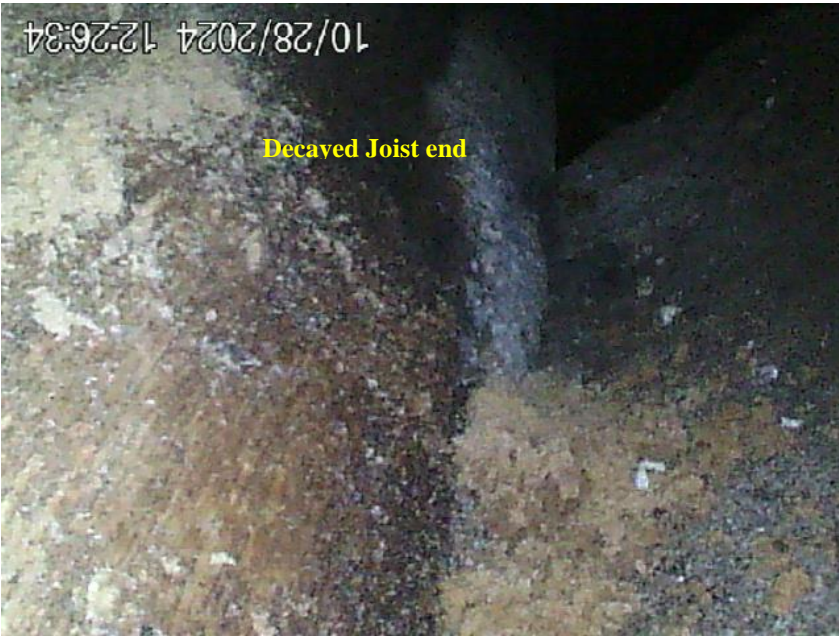
*This Fibre Optic photo is the sub-floor area just below the above photo. It shows the joist end where touching the outer wall to be decayed by Wet Rot.*

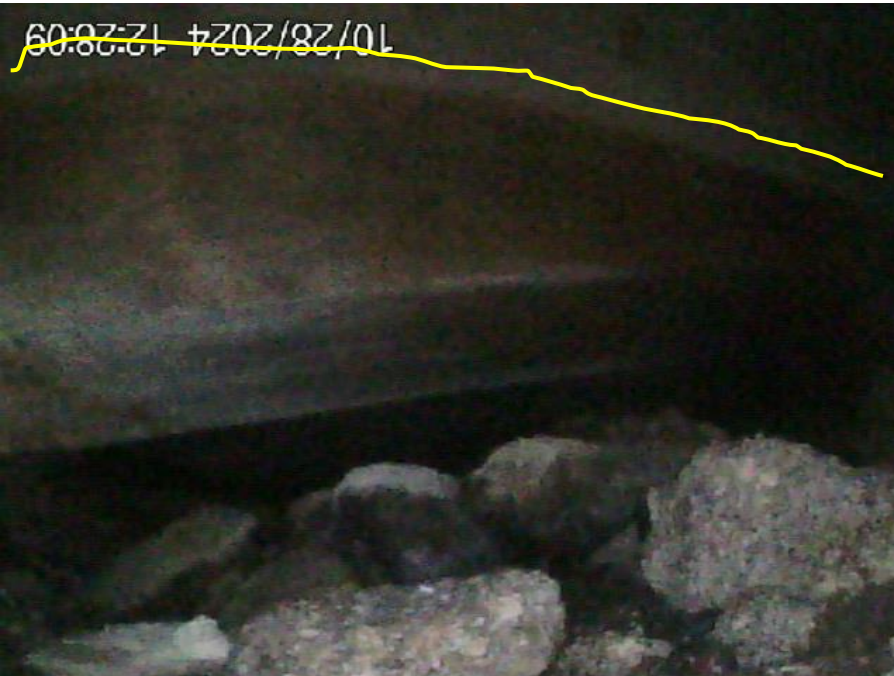
*This Fibre Optic photo shows a damp "crown" (as highlighted), on the bottom of the joist a bit further back from the outer wall, which is a result of the joist being in close proximity to a damp solum. This joist section is beginning to decay.*

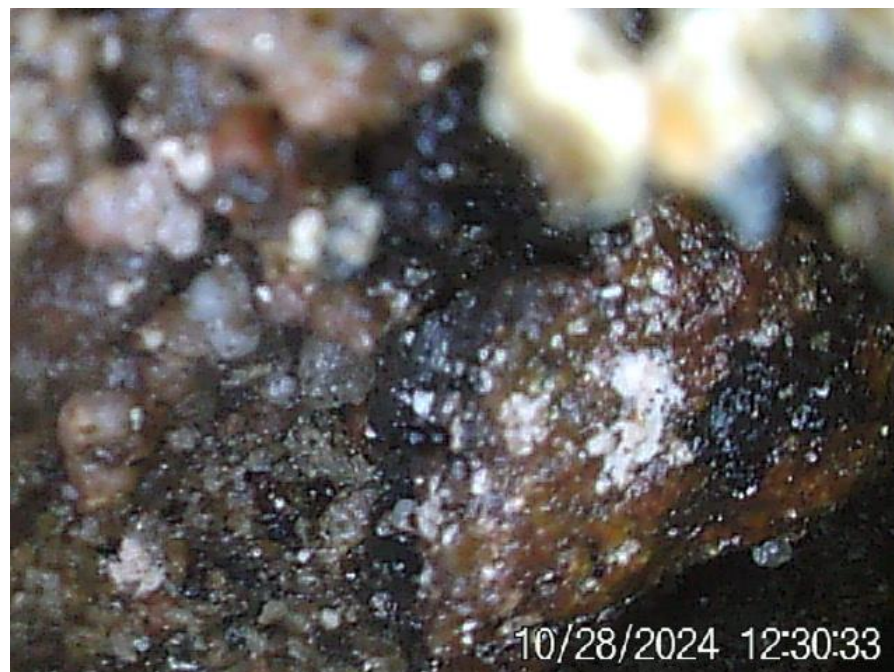
*This Fibre Optic photo is the solum in the immediate area and the solum was found to be wet.*

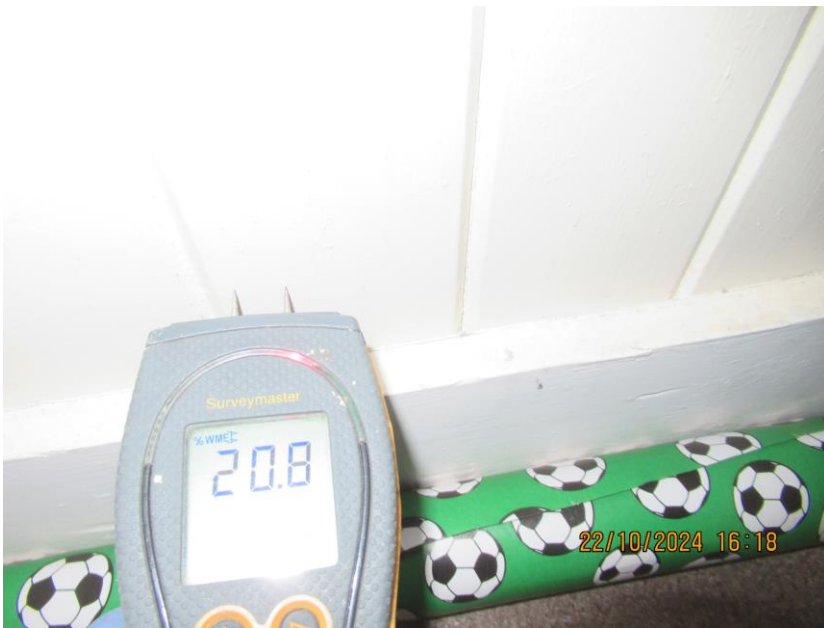
*M/C (Surface Moisture Content, as per the above chart), at 20.8% is just outside of the tolerable levels. .*

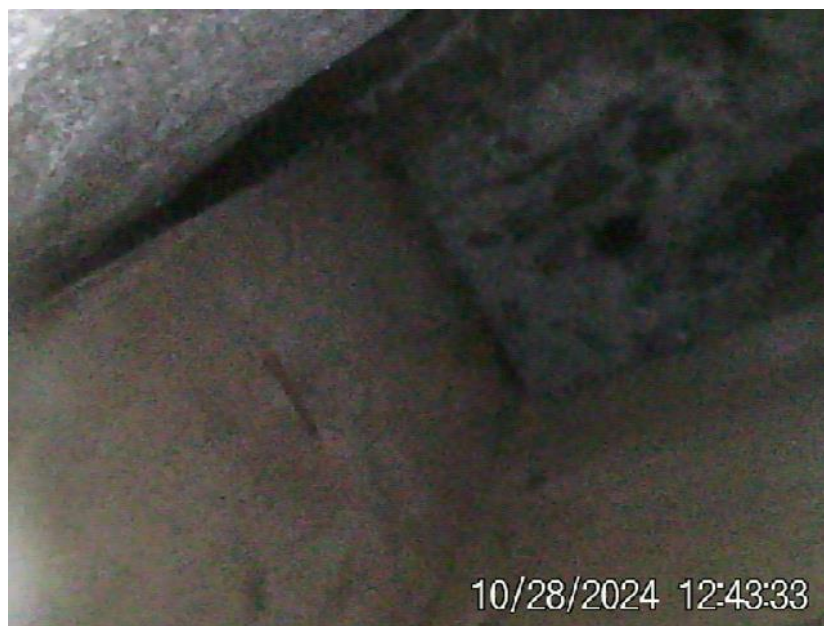
*Sub-floor joist end seen appears to be sound.*

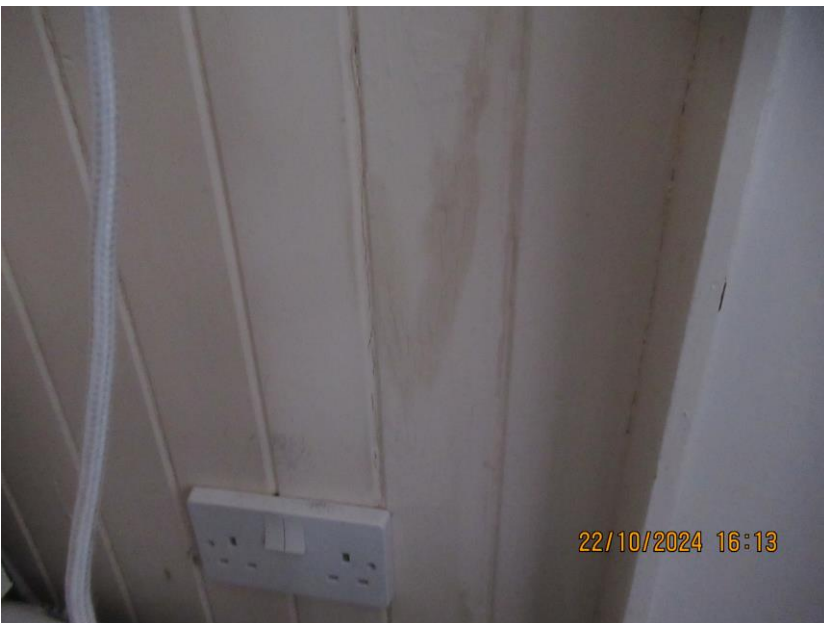
*Damp staining was noted in the linings of the gable wall of this room to the left of the fire opening.*

*M/C (Surface Moisture Content, as per the above chart), at 36.8% is slightly high.*

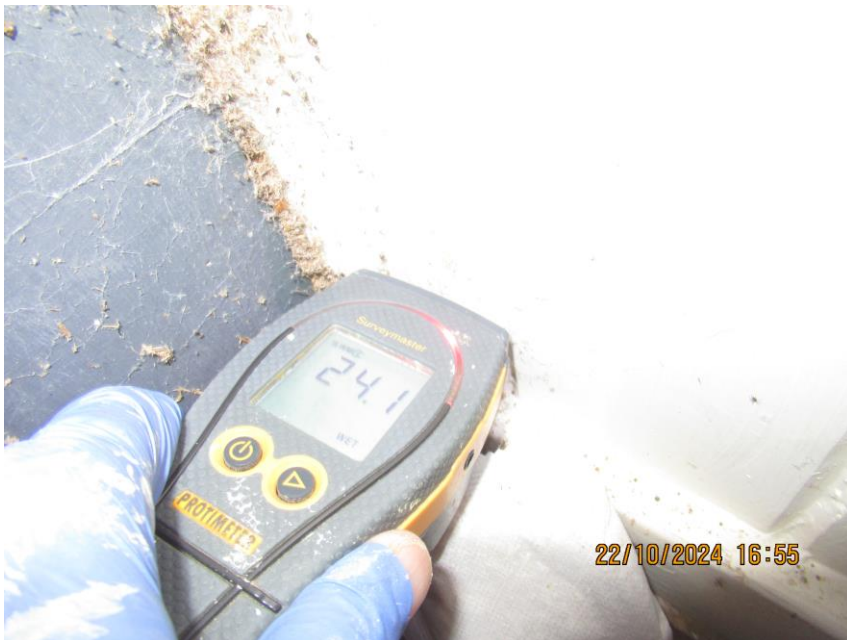
*M/C (Surface Moisture Content, as per the above chart), at 24.1% recorded at the lower front door ingo and just above tolerable levels. .*

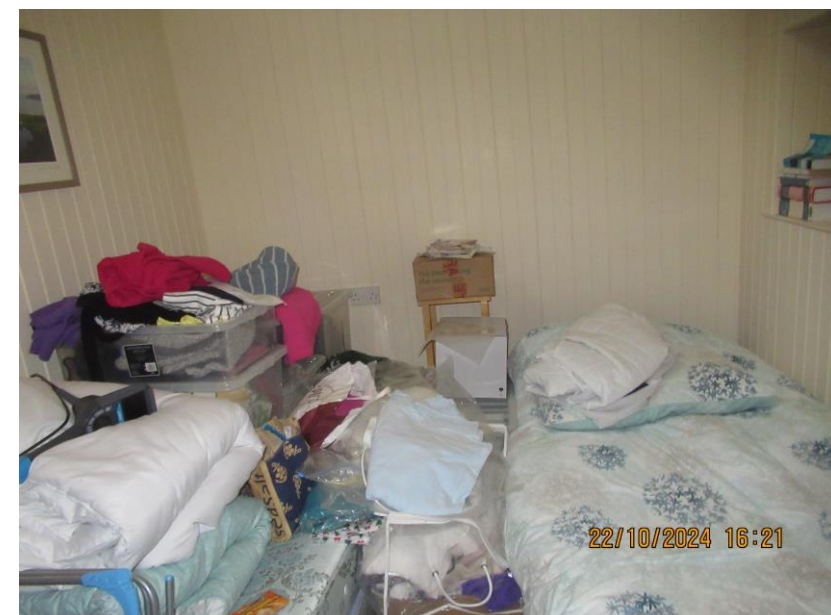
*There was an abundance of furniture and stored items in the bedroom.*

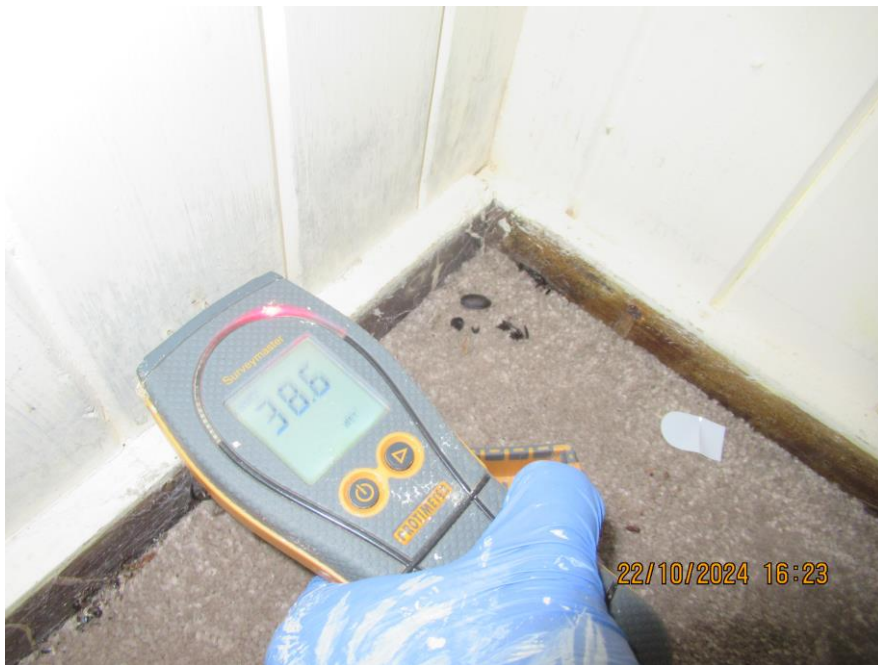
*M/C (Surface Moisture Content, as per the above chart), at 38.6% recorded in the rear right-hand lower wall is slightly high.*

*You will note the slight damp staining in the lower wall linings.*

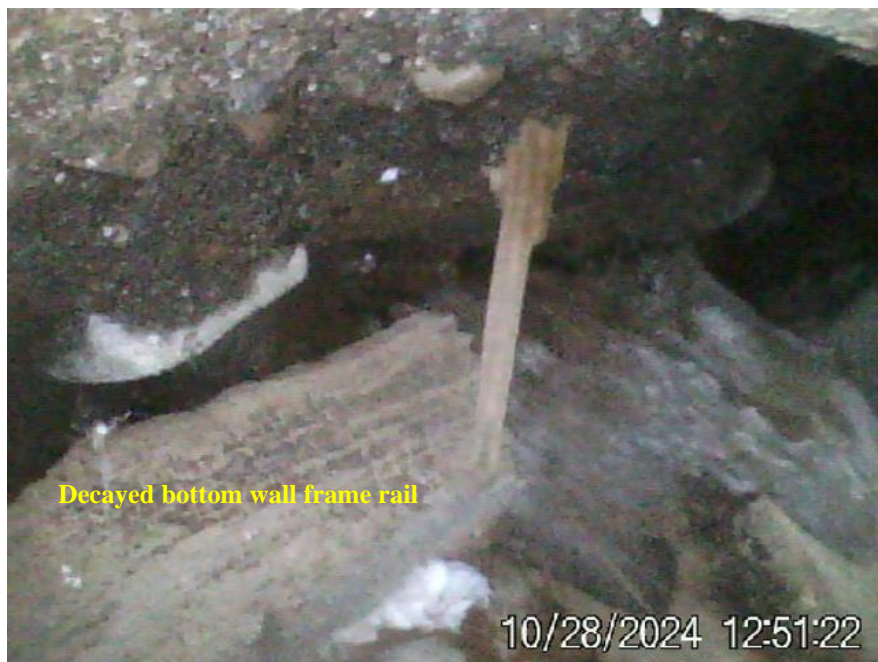
**Decayed bottom wall frame rail**

*This Fibre Optic photo shows the cavity between the lower linings and the external wall. There is a debris build up at the bottom of this void and you will note that the bottom rail of the timber frame is decayed, and the timber has broken down.*

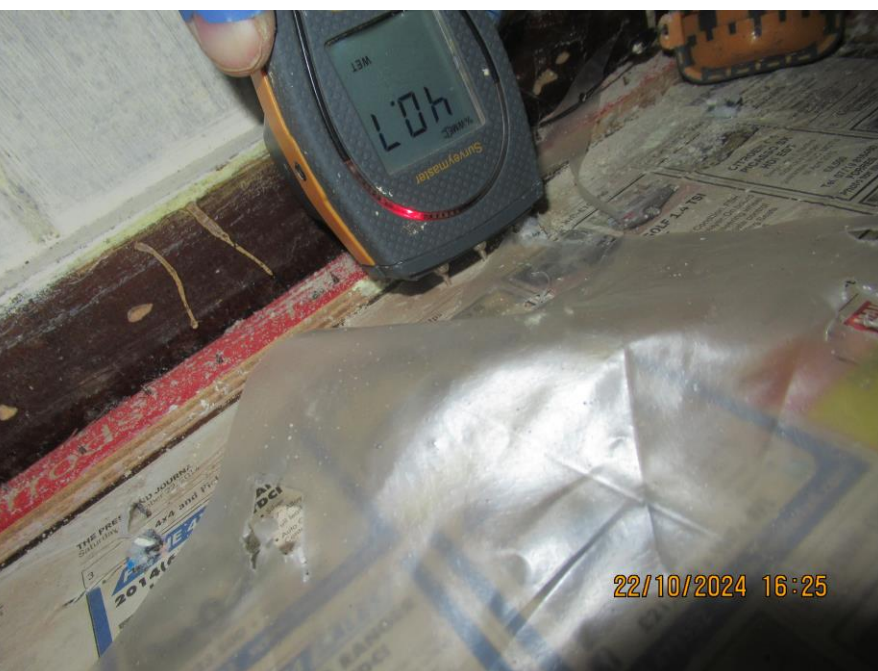
*M/C (Surface Moisture Content, as per the above chart), at 40.7% recorded from the surface of the floor in the same corner as the above photos is high.*

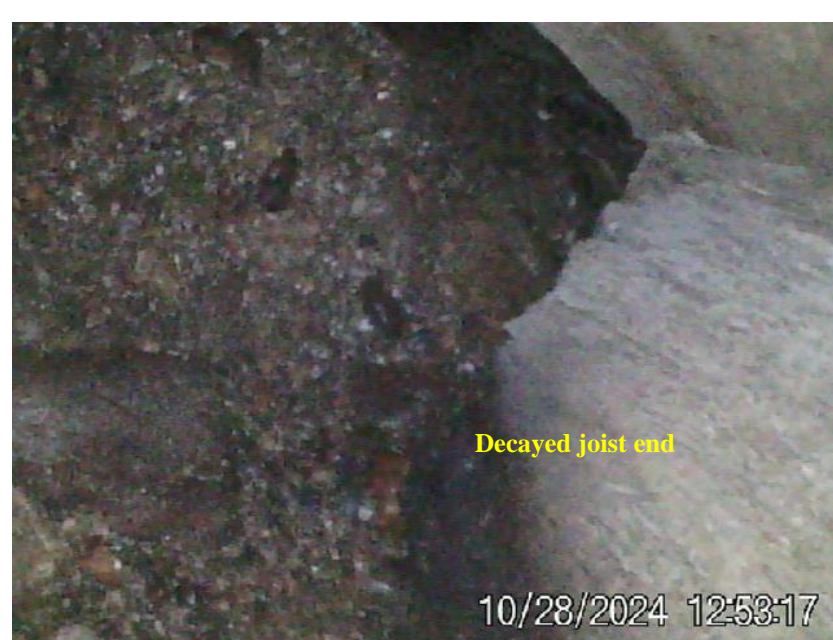
*This Fibre Optic photo is the sub-floor joist end taken just below the above photo.*

*It shows the joist ends near the outer wall to be decayed.*

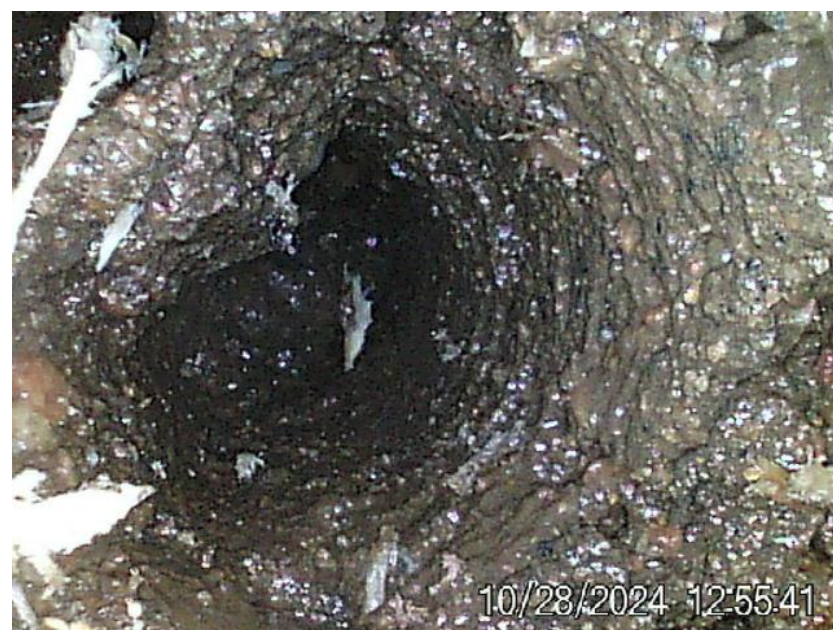
*This Fibre Optic photo is the solum where the drill bit actually entered the solum near the rear wall. The solum in this area is actually "mud".*

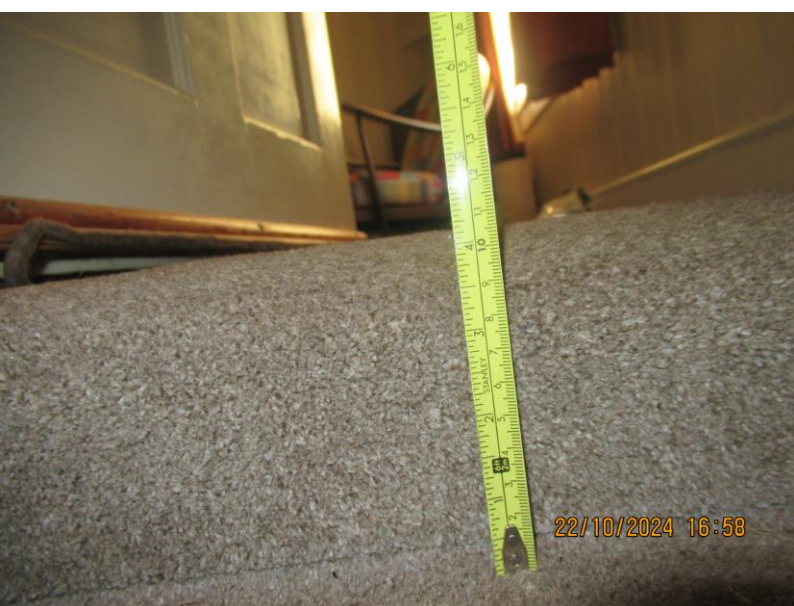
*This timber suspended floor is raised higher than the rest of the floors within the original cottage by approximately 100mm.*

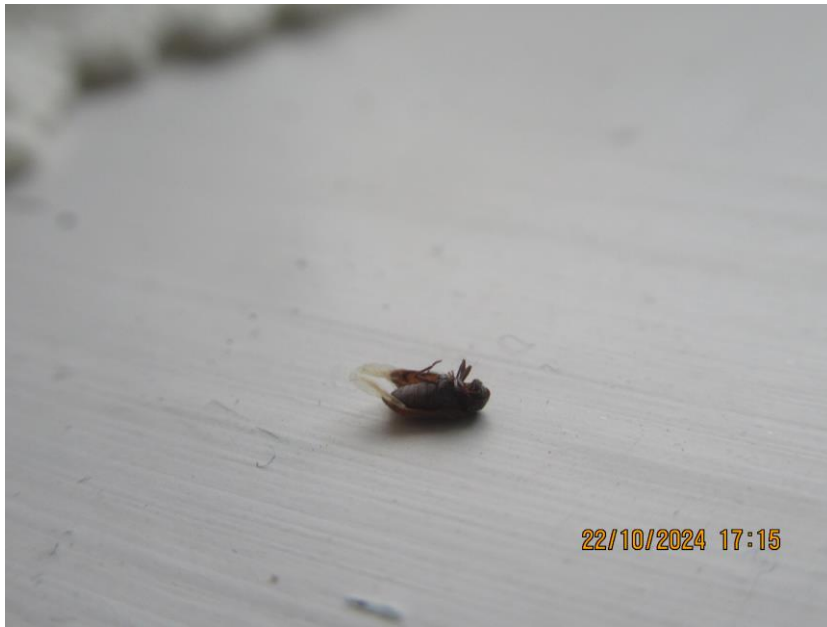
*This photo shows the carcass of an adult furniture beetle (woodworm adult), that was found on the window sill. This demonstrates that there is an active woodworm infestation at ground level.*

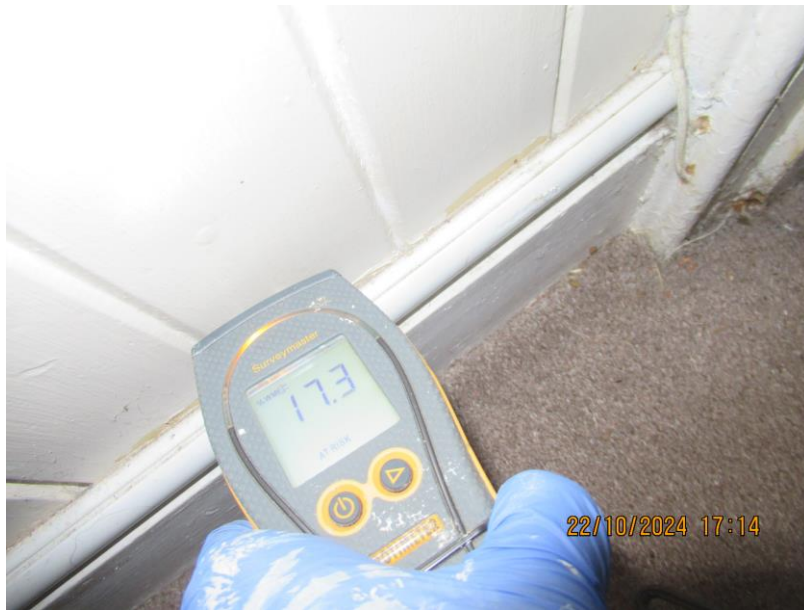
*M/C (Surface Moisture Content, as per the above chart), at 17.3% recorded at the lower, rear right-hand wall next to the entrance into the room from the rear entrance is within tolerable levels.*

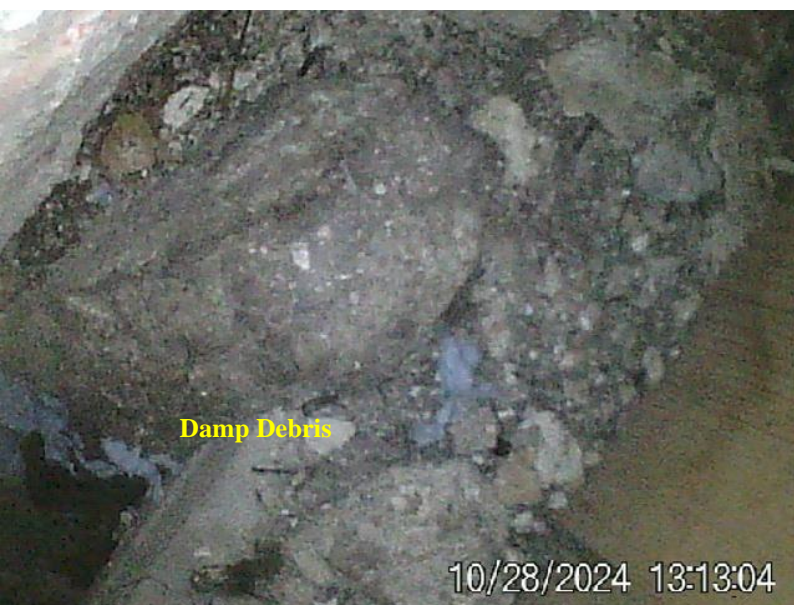
*This Fibre-Optic photo taken in behind the area of the above photo, shows (also indicated on the sketch above), the painted masonry wall on the left and the bottom of the lining timbers on the right. There is a slight damp "tide line" at the bottom of the timber linings.*

*This is a result of the debris (between the damp external wall and the linings seen in the middle of the photo), bridging the damp from the masonry to the lining boards.*

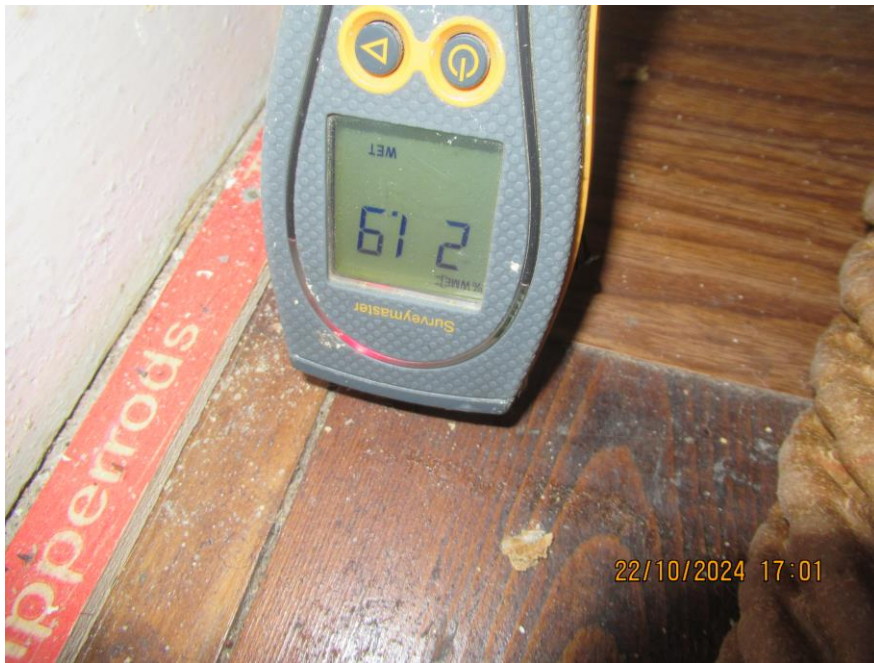
*M/C (Surface Moisture Content, as per the above chart), at 21.9% taken off the surface of the floor in the rear right-hand corner, (just below the Fibre-Optic wall inspection hole), to be just above the tolerable levels.*

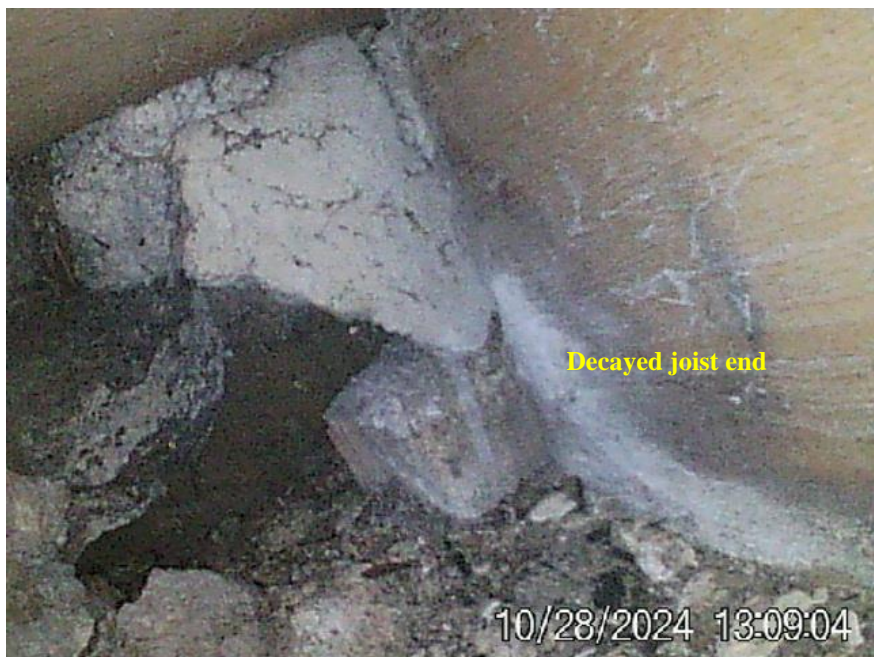
*This Fibre Optic photo is the sub-floor joist end taken just below the above photo.*

*It shows the joist ends near the outer wall to be decayed.*

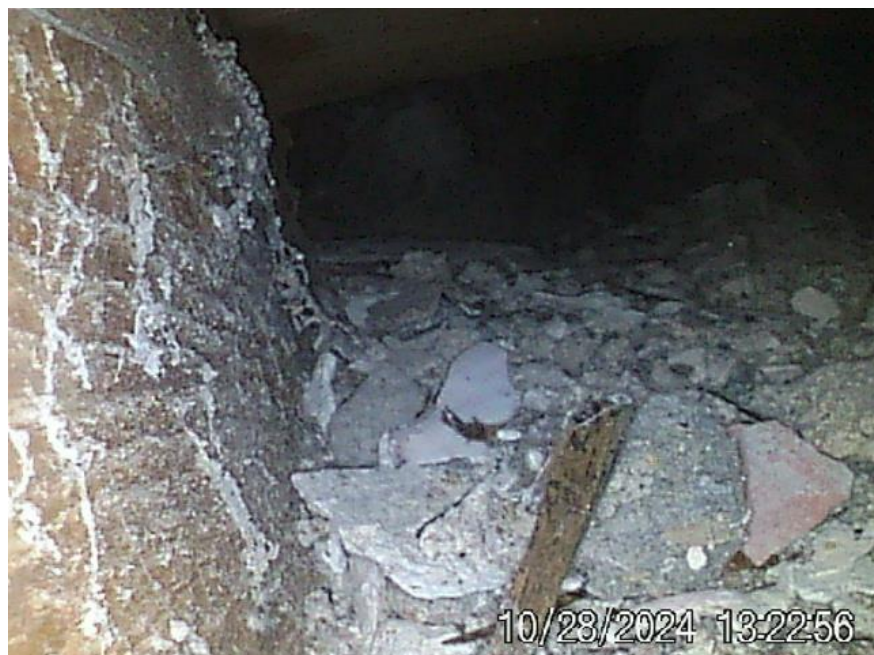
*This Fibre Optic photo shows the joist end on the front wall that is embedded in debris. I was unable to determine if the end was decayed due to the presences of the debris. However, you will note the damp staining at the end of the timber which is an indicator that the end may be affected by decay.*
