# YOUR ONESURVEY HOME REPORT

Castlerock  
Glenelg, Kyle  
IV40 8JZ

# SINGLE SURVEY

***Alder Specialist Building Surveyors Ltd***

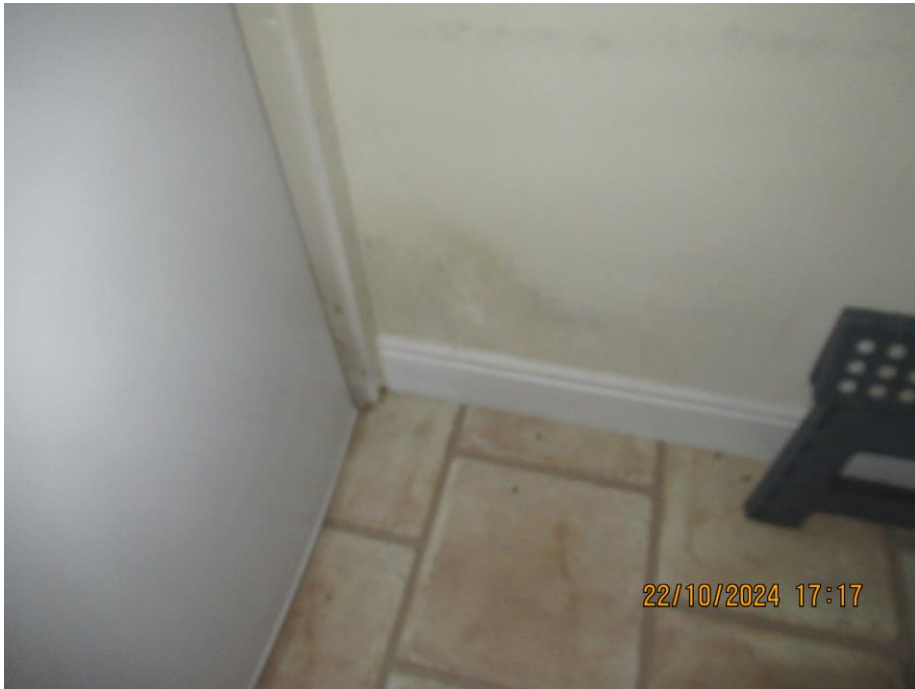
*Obvious dampness was noted in the lower wall that divides the kitchen from the lounge. This area is just in front the fridge.*

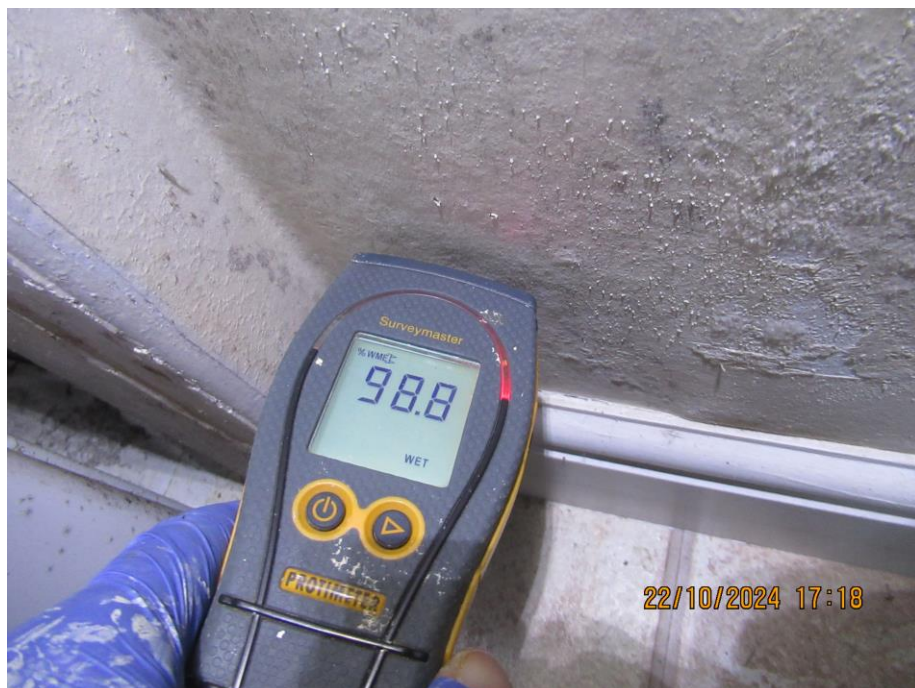
*M/C (Surface Moisture Content, as per the above chart), at 98.8% is excessive.*

*I was unable to determine the cause of this damp for reasons stated. However, I refer to my external observations (Page 3), as a possible source of the damp. This will require further investigations.*

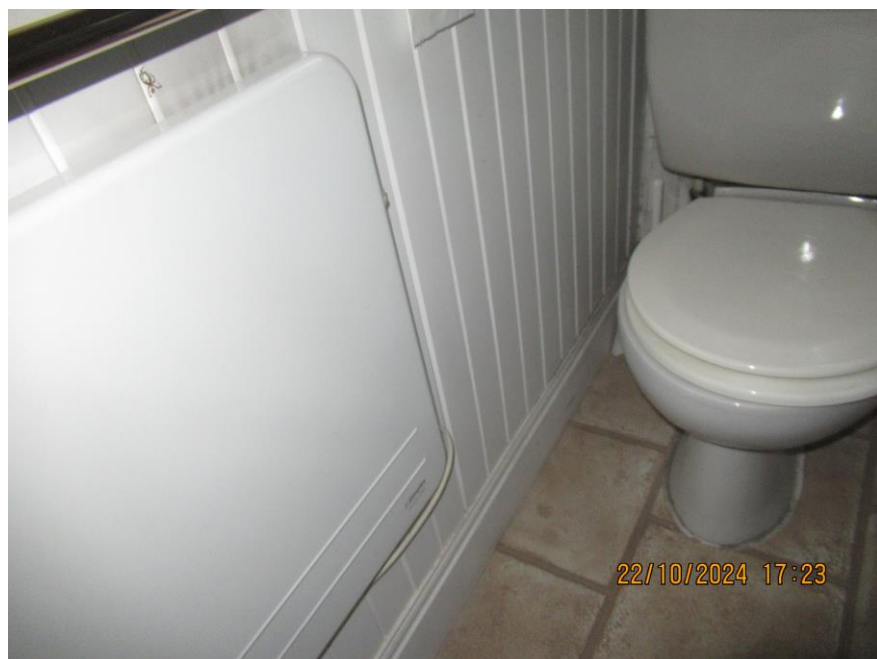
*Where moisture profiling was executed, the readings recorded off the surfaces of the lining timber were found to be within tolerable levels.*
