# YOUR ONESURVEY HOME REPORT

Castlerock  
Glenelg, Kyle  
IV40 8JZ

# SINGLE SURVEY

***Alder Specialist Building Surveyors Ltd***

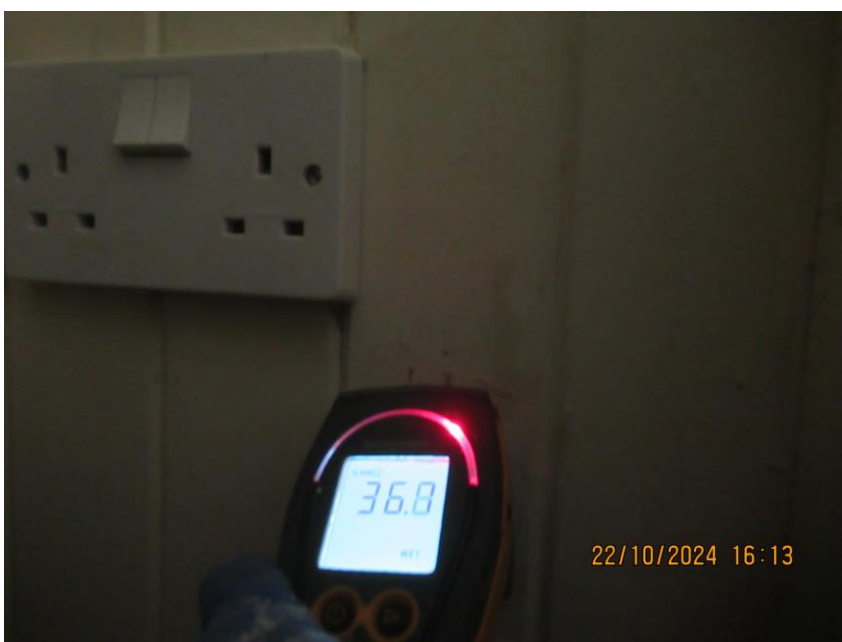
*Damp staining was noted in the linings of the gable wall of this room to the left of the fire opening.*

*M/C (Surface Moisture Content, as per the above chart), at 36.8% is slightly high.*
