HOME REPORT

13 Breadalbane Terrace
Wick
KW1 5AT

Energy Performance Certificate (EPC)

Single Survey

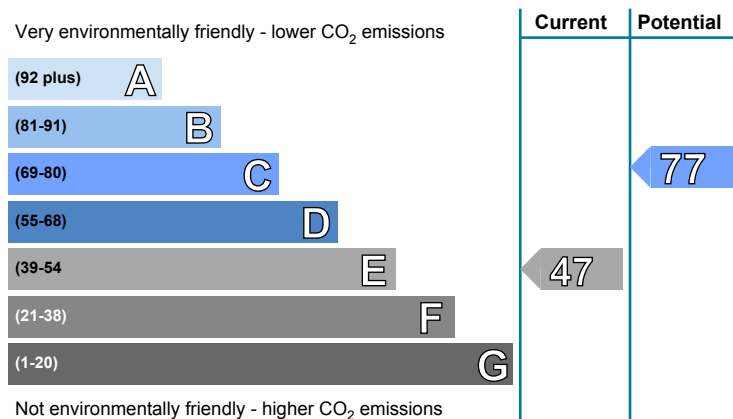
Environmental Impact (CO₂) Rating

This graph shows the effect of your home on the environment in terms of carbon dioxide (CO₂) emissions. The higher the rating, the less impact it has on the environment.

Your current rating is **band E (47)**. The average rating for EPCs in Scotland is **band D (59)**.

The potential rating shows the effect of undertaking all of the improvement measures listed within your recommendations report.
