HOME REPORT

4 ROSE STREET
WICK
KW1 5EX

Energy Performance Certificate (EPC)

4 ROSE STREET, WICK, KW1 5EX

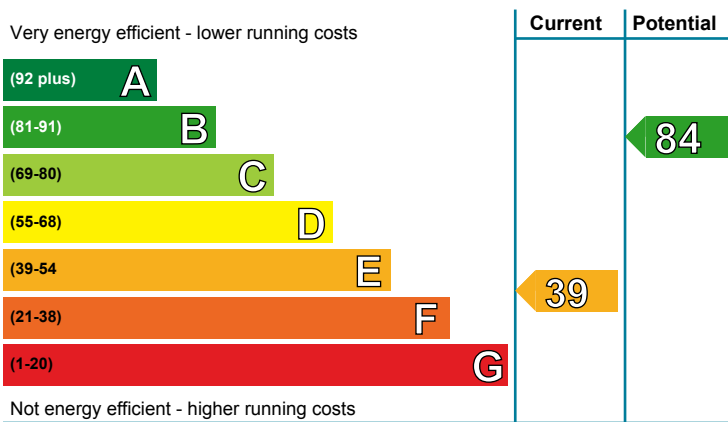
Energy Efficiency Rating

This graph shows the current efficiency of your home, taking into account both energy efficiency and fuel costs. The higher this rating, the lower your fuel bills are likely to be.

Your current rating is **band E (39)**. The average rating for EPCs in Scotland is **band D (61)**.

The potential rating shows the effect of undertaking all of the improvement measures listed within your recommendations report.

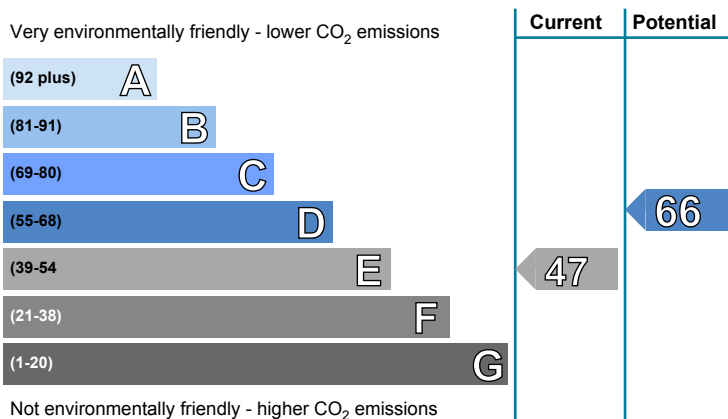
Environmental Impact (CO₂) Rating

This graph shows the effect of your home on the environment in terms of carbon dioxide (CO₂) emissions. The higher the rating, the less impact it has on the environment.

Your current rating is **band E (47)**. The average rating for EPCs in Scotland is **band D (59)**.

The potential rating shows the effect of undertaking all of the improvement measures listed within your recommendations report.
