# HOME REPORT

13 UNION STREET  
WICK  
KW1 5ED

13 UNION STREET, WICK, KW1 5ED

# Single Survey

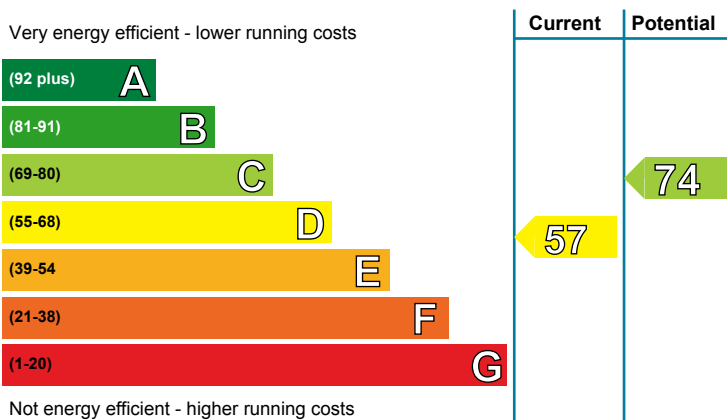
## Energy Efficiency Rating

This graph shows the current efficiency of your home, taking into account both energy efficiency and fuel costs. The higher this rating, the lower your fuel bills are likely to be.

Your current rating is **band D (57)**. The average rating for EPCs in Scotland is **band D (61)**.

The potential rating shows the effect of undertaking all of the improvement measures listed within your recommendations report.

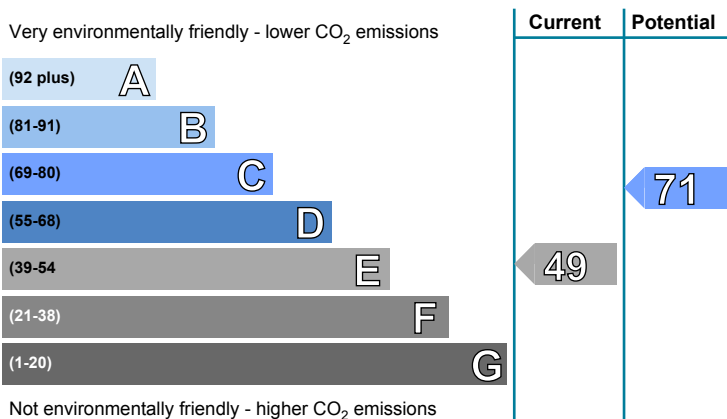
## Environmental Impact (CO<sub>2</sub>) Rating

This graph shows the effect of your home on the environment in terms of carbon dioxide (CO<sub>2</sub>) emissions. The higher the rating, the less impact it has on the environment.

Your current rating is **band E (49)**. The average rating for EPCs in Scotland is **band D (59)**.

The potential rating shows the effect of undertaking all of the improvement measures listed within your recommendations report.
