# HOME REPORT

2 ROYAL BANK HOUSE  
VICTORIA PLACE  
WICK  
KW1 4AP

# Energy Performance Certificate (EPC)

# Single Survey

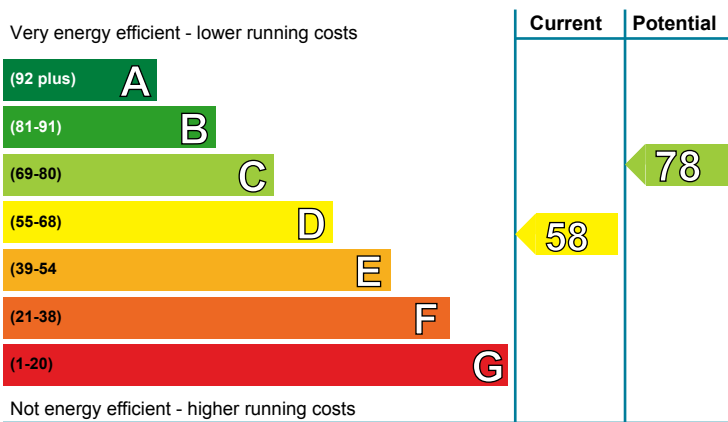
## Energy Efficiency Rating

This graph shows the current efficiency of your home, taking into account both energy efficiency and fuel costs. The higher this rating, the lower your fuel bills are likely to be.

Your current rating is **band D (58)**. The average rating for EPCs in Scotland is **band D (61)**.

The potential rating shows the effect of undertaking all of the improvement measures listed within your recommendations report.

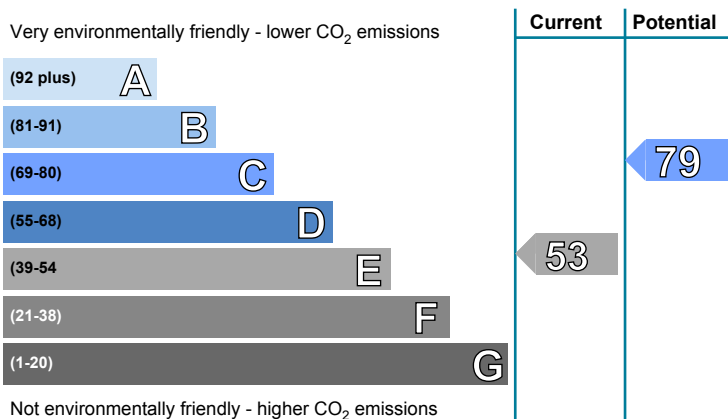
## Environmental Impact (CO<sub>2</sub>) Rating

This graph shows the effect of your home on the environment in terms of carbon dioxide (CO<sub>2</sub>) emissions. The higher the rating, the less impact it has on the environment.

Your current rating is **band E (53)**. The average rating for EPCs in Scotland is **band D (59)**.

The potential rating shows the effect of undertaking all of the improvement measures listed within your recommendations report.
