HOME REPORT

86 HENRIETTA STREET
WICK
KW1 4HG

Energy Performance Certificate (EPC)

86 HENRIETTA STREET, WICK, KW1 4HG

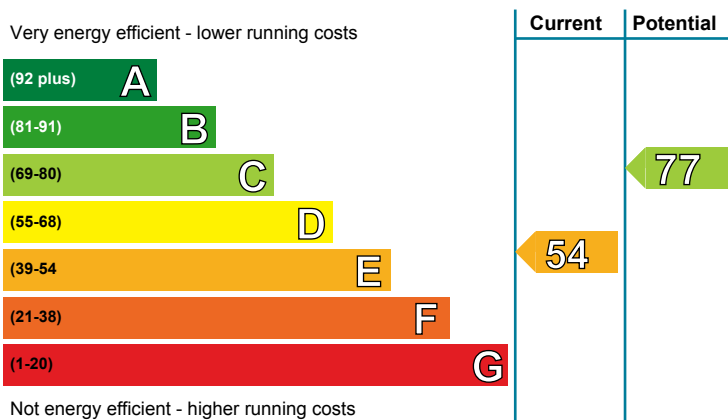
Energy Efficiency Rating

This graph shows the current efficiency of your home, taking into account both energy efficiency and fuel costs. The higher this rating, the lower your fuel bills are likely to be.

Your current rating is **band E (54)**. The average rating for EPCs in Scotland is **band D (61)**.

The potential rating shows the effect of undertaking all of the improvement measures listed within your recommendations report.

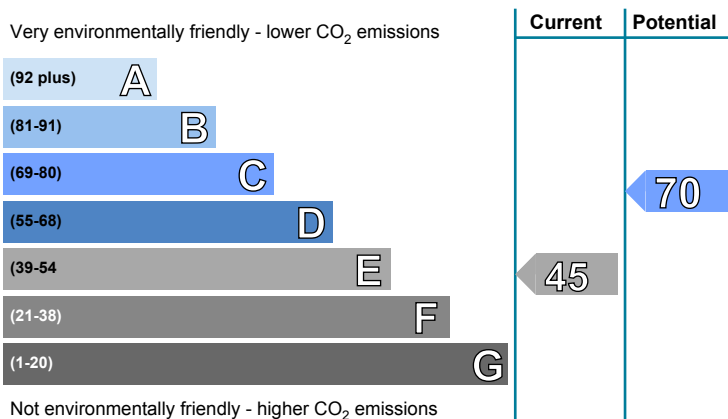
Environmental Impact (CO₂) Rating

This graph shows the effect of your home on the environment in terms of carbon dioxide (CO₂) emissions. The higher the rating, the less impact it has on the environment.

Your current rating is **band E (45)**. The average rating for EPCs in Scotland is **band D (59)**.

The potential rating shows the effect of undertaking all of the improvement measures listed within your recommendations report.
