HOME REPORT

FLAT
4 THE COOPERAGE
ALBERT STREET
WICK
KW1 5BQ

ENERGY PERFORMANCE CERTIFICATE

SINGLE SURVEY

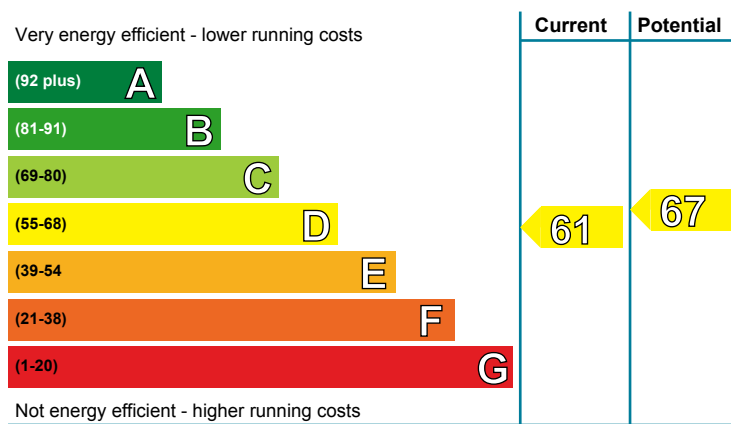
Energy Efficiency Rating

This graph shows the current efficiency of your home, taking into account both energy efficiency and fuel costs. The higher this rating, the lower your fuel bills are likely to be.

Your current rating is **band D (61)**. The average rating for EPCs in Scotland is **band D (61)**.

The potential rating shows the effect of undertaking all of the improvement measures listed within your recommendations report.

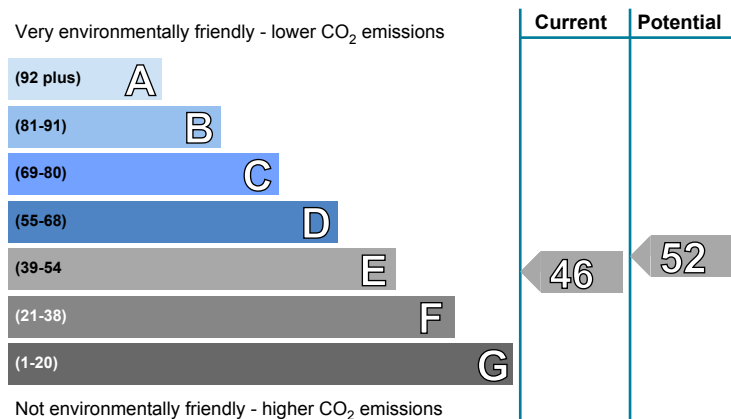
Environmental Impact (CO₂) Rating

This graph shows the effect of your home on the environment in terms of carbon dioxide (CO₂) emissions. The higher the rating, the less impact it has on the environment.

Your current rating is **band E (46)**. The average rating for EPCs in Scotland is **band D (59)**.

The potential rating shows the effect of undertaking all of the improvement measures listed within your recommendations report.
