HOME REPORT

8 MOWAT PLACE
WICK
KW1 4JR

Energy Performance Certificate (EPC)

8 MOWAT PLACE, WICK, KW1 4JR

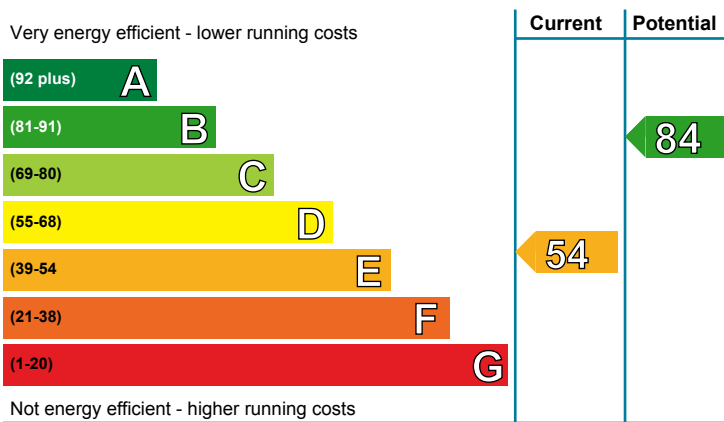
Energy Efficiency Rating

This graph shows the current efficiency of your home, taking into account both energy efficiency and fuel costs. The higher this rating, the lower your fuel bills are likely to be.

Your current rating is **band E (54)**. The average rating for EPCs in Scotland is **band D (61)**.

The potential rating shows the effect of undertaking all of the improvement measures listed within your recommendations report.

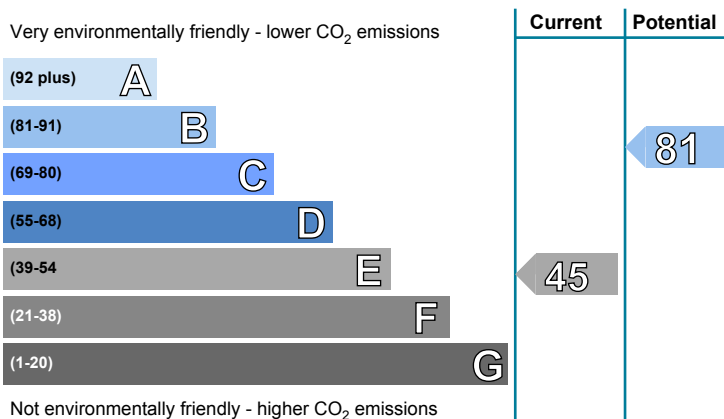
Environmental Impact (CO₂) Rating

This graph shows the effect of your home on the environment in terms of carbon dioxide (CO₂) emissions. The higher the rating, the less impact it has on the environment.

Your current rating is **band E (45)**. The average rating for EPCs in Scotland is **band D (59)**.

The potential rating shows the effect of undertaking all of the improvement measures listed within your recommendations report.
