Energy Performance Certificate

OLD SCHOOLHOUSE, MEY, THURSO, KW14 8XH

Dwelling type: Detached house
Date of assessment: 06 December 2023
Date of certificate: 07 December 2023
Total floor area: 153 m²
Primary Energy Indicator: 407 kWh/m²/year

Reference number: 8117-4122-9009-0606-7202
Type of assessment: RdSAP, existing dwelling
Approved Organisation: Elmhurst
Main heating and fuel: Boiler and radiators, oil

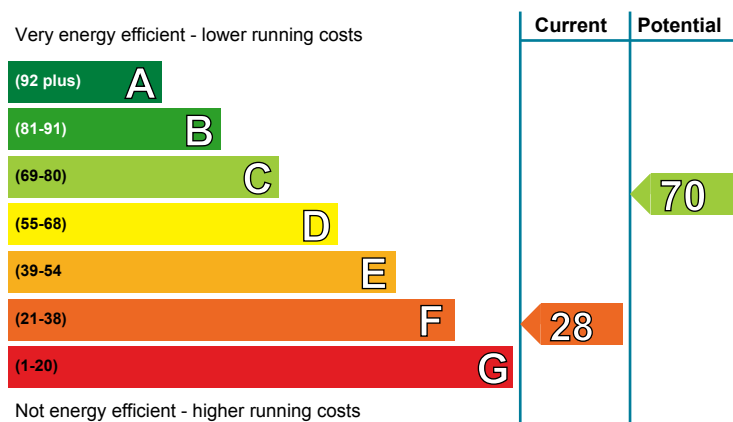
Energy Efficiency Rating

This graph shows the current efficiency of your home, taking into account both energy efficiency and fuel costs. The higher this rating, the lower your fuel bills are likely to be.

Your current rating is **band F (28)**. The average rating for EPCs in Scotland is **band D (61)**.

The potential rating shows the effect of undertaking all of the improvement measures listed within your recommendations report.

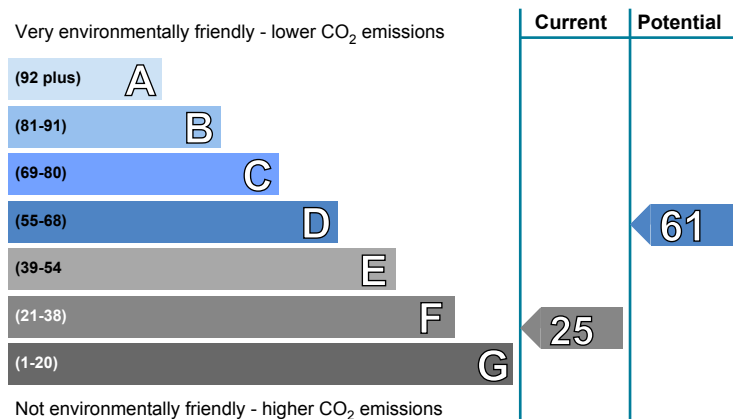
Environmental Impact (CO₂) Rating

This graph shows the effect of your home on the environment in terms of carbon dioxide (CO₂) emissions. The higher the rating, the less impact it has on the environment.

Your current rating is **band F (25)**. The average rating for EPCs in Scotland is **band D (59)**.

The potential rating shows the effect of undertaking all of the improvement measures listed within your recommendations report.
