YOUR ONESURVEY  
**HOME REPORT**

Roadside  
Tannach  
by Wick  
KW1 5SF

# Document Index

# SINGLE SURVEY

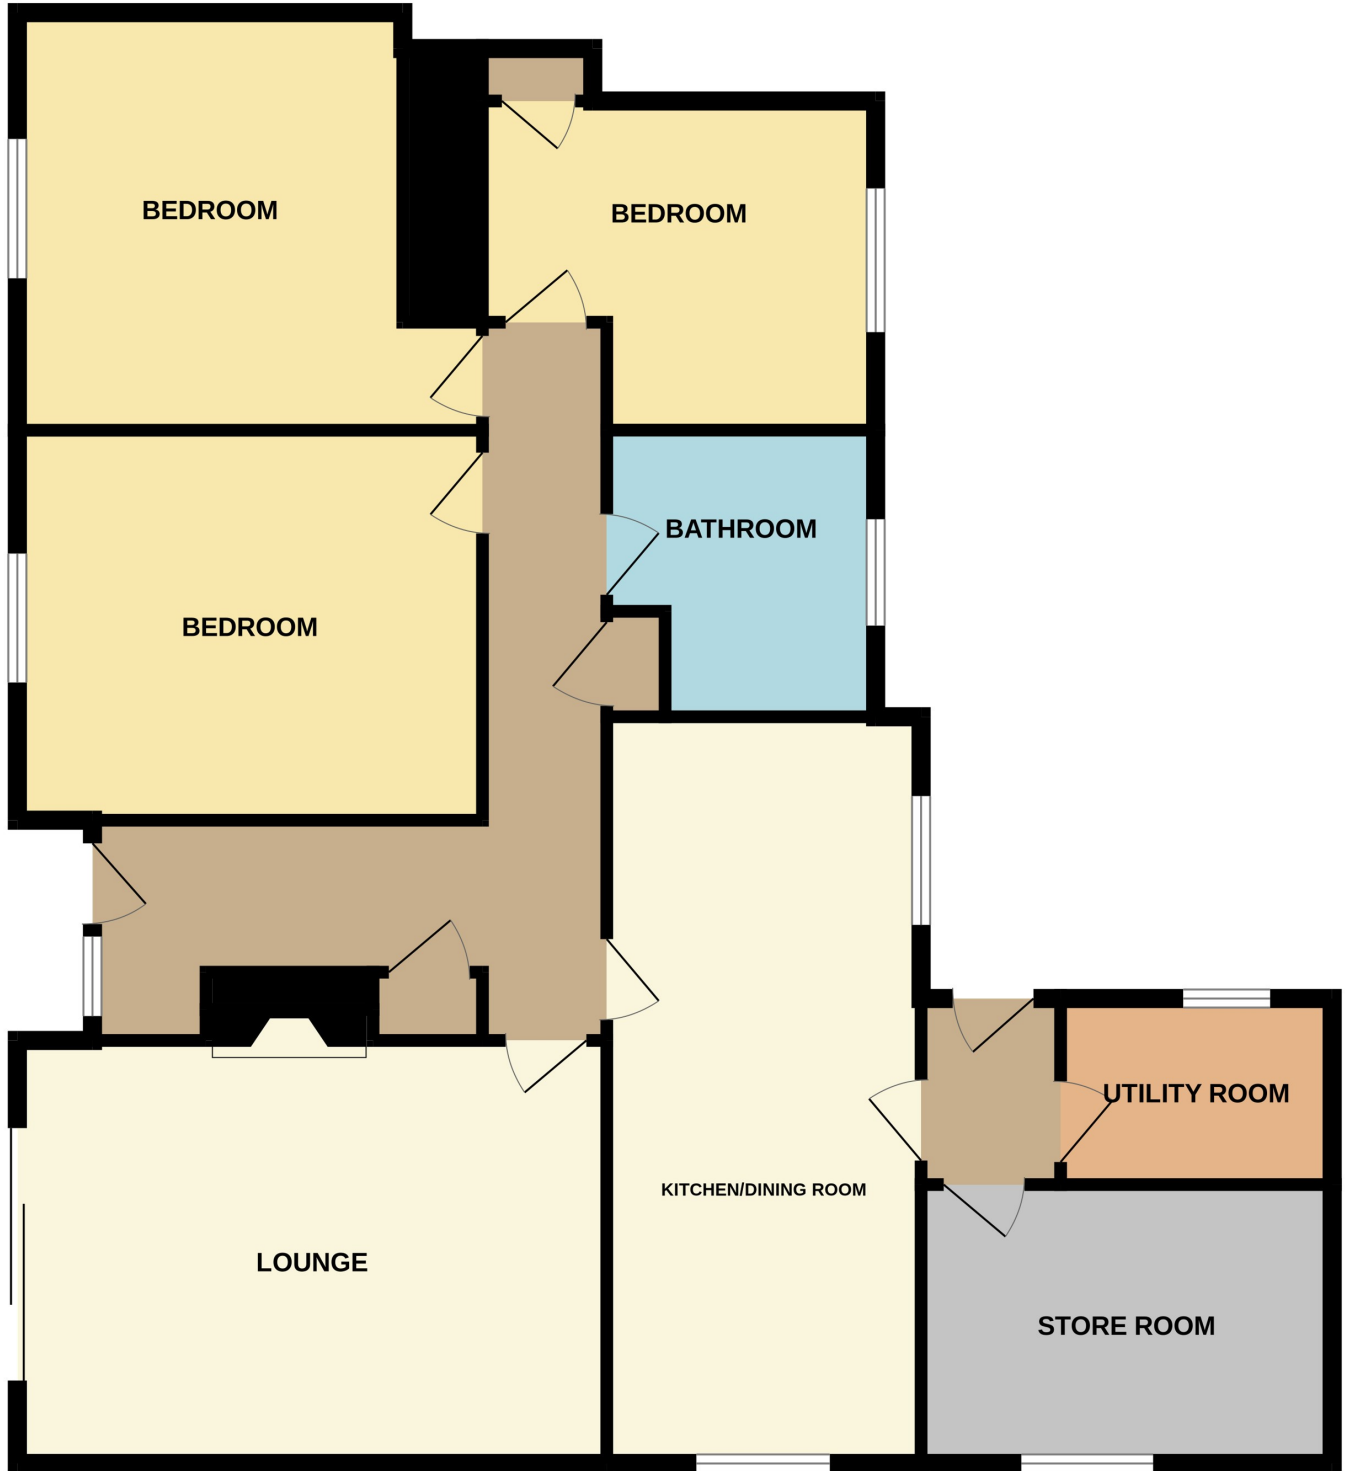
Whilst every attempt has been made to ensure the accuracy of the floorplan contained here, measurements of doors, windows, rooms and any other items are approximate and no responsibility is taken for any error, omission or mis-statement. This plan is for illustrative purposes only and should be used as such by any prospective purchaser. The services, systems and appliances shown have not been tested and no guarantee as to their operability or efficiency can be given.  
Made with Metropix ©2024
