YOUR ONESURVEY
HOME REPORT

Tigh Na Failte
Jamestown, Strathpeffer
IV14 9ER

SINGLE SURVEY

Single Survey

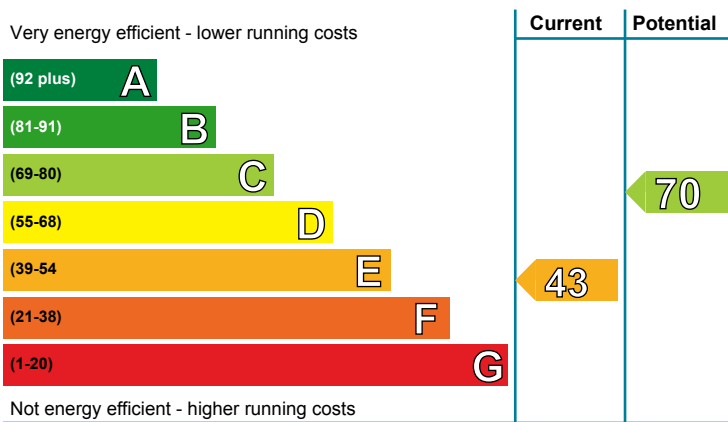
Energy Efficiency Rating

This graph shows the current efficiency of your home, taking into account both energy efficiency and fuel costs. The higher this rating, the lower your fuel bills are likely to be.

Your current rating is **band E (43)**. The average rating for EPCs in Scotland is **band D (61)**.

The potential rating shows the effect of undertaking all of the improvement measures listed within your recommendations report.

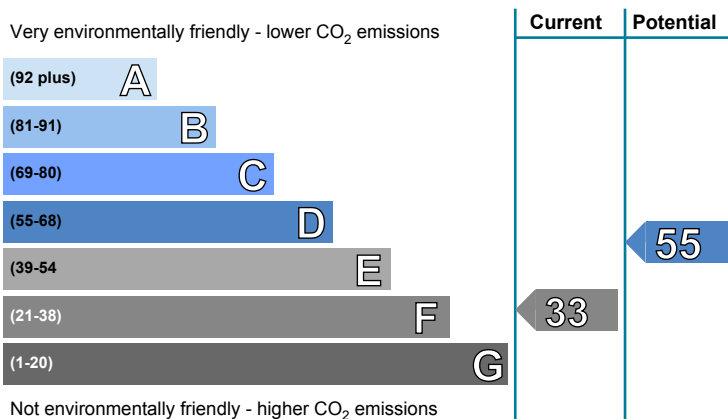
Environmental Impact (CO₂) Rating

This graph shows the effect of your home on the environment in terms of carbon dioxide (CO₂) emissions. The higher the rating, the less impact it has on the environment.
