YOUR ONESURVEY
HOME REPORT

31 Highfield Avenue
Inverness
IV3 8RW

SINGLE SURVEY

Single Survey

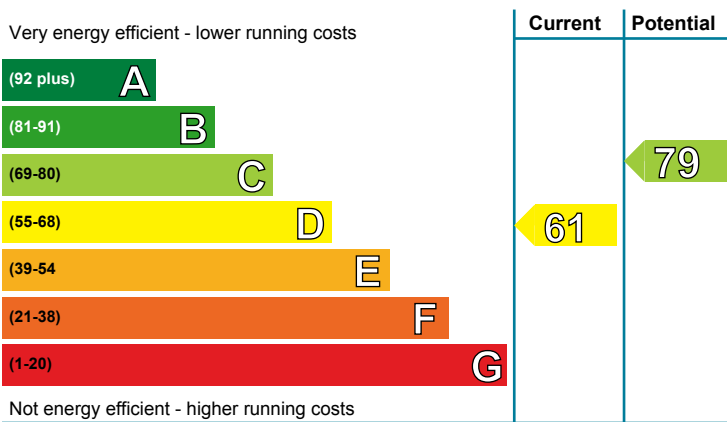
Energy Efficiency Rating

This graph shows the current efficiency of your home, taking into account both energy efficiency and fuel costs. The higher this rating, the lower your fuel bills are likely to be.

Your current rating is **band D (61)**. The average rating for EPCs in Scotland is **band D (61)**.

The potential rating shows the effect of undertaking all of the improvement measures listed within your recommendations report.
