YOUR ONESURVEY  
**HOME REPORT**

43 St. Valery Place  
Ullapool  
IV26 2TD

# SINGLE SURVEY

# Single Survey

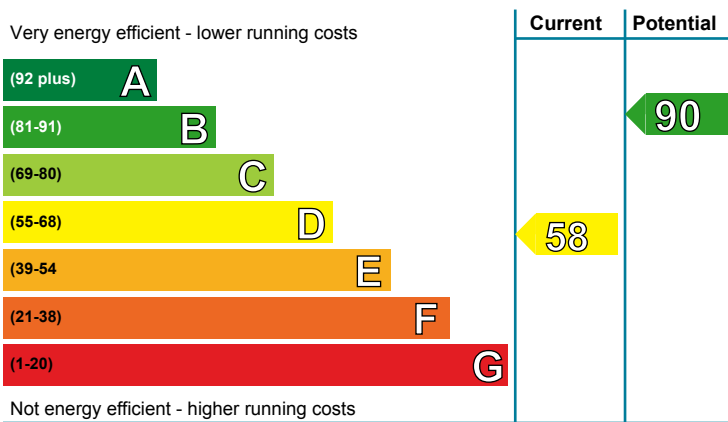
## Energy Efficiency Rating

This graph shows the current efficiency of your home, taking into account both energy efficiency and fuel costs. The higher this rating, the lower your fuel bills are likely to be.

Your current rating is **band D (58)**. The average rating for EPCs in Scotland is **band D (61)**.

The potential rating shows the effect of undertaking all of the improvement measures listed within your recommendations report.
