YOUR ONESURVEY HOME REPORT

1 Mill Street Dingwall IV15 9PX

SINGLE Survey

Single Survey

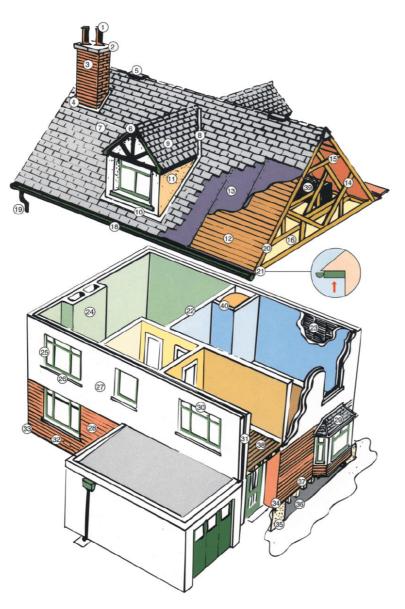
Sectional Diagram showing elements of a typical house

Reference may be made in this report to some or all of the above component parts of the property. This diagram may assist you in locating and understanding these items.
