YOUR ONESURVEY HOME REPORT

110 Murray Terrace
Smithton
Inverness
IV2 7WY

SINGLE SURVEY

Single Survey

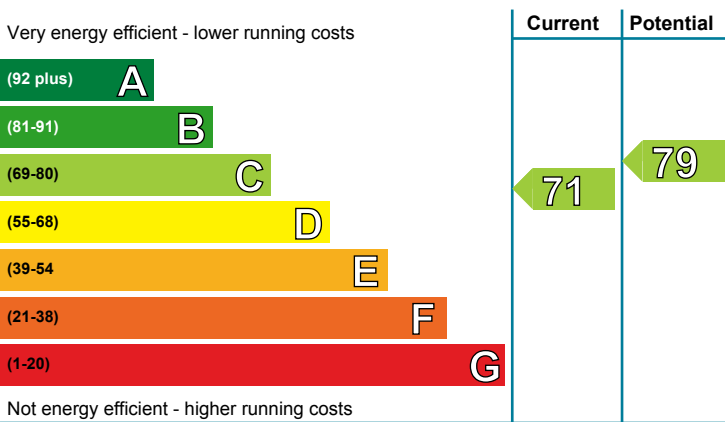
Energy Efficiency Rating

This graph shows the current efficiency of your home, taking into account both energy efficiency and fuel costs. The higher this rating, the lower your fuel bills are likely to be.

Your current rating is **band C (71)**. The average rating for EPCs in Scotland is **band D (61)**.

The potential rating shows the effect of undertaking all of the improvement measures listed within your recommendations report.

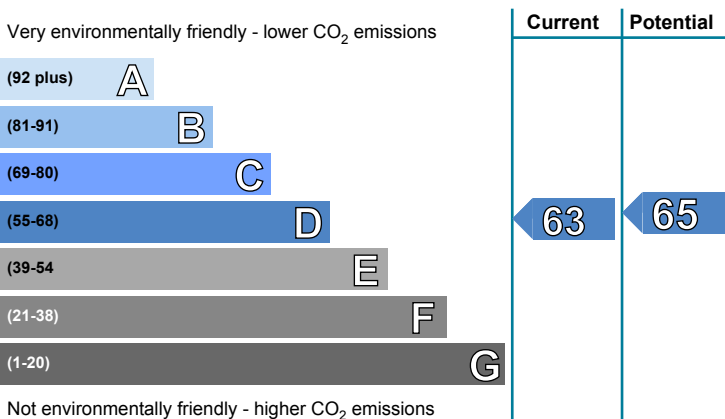
Environmental Impact (CO₂) Rating

This graph shows the effect of your home on the environment in terms of carbon dioxide (CO₂) emissions. The higher the rating, the less impact it has on the environment.
