HOME REPORT

3 CREAG LOISGTE PLACE
PORTGOWER
HELMSDALE
KW8 6HW

Energy Performance Certificate (EPC)

3 Creag Loisgte Place, Portgower, Helmsdale, KW8 6HW

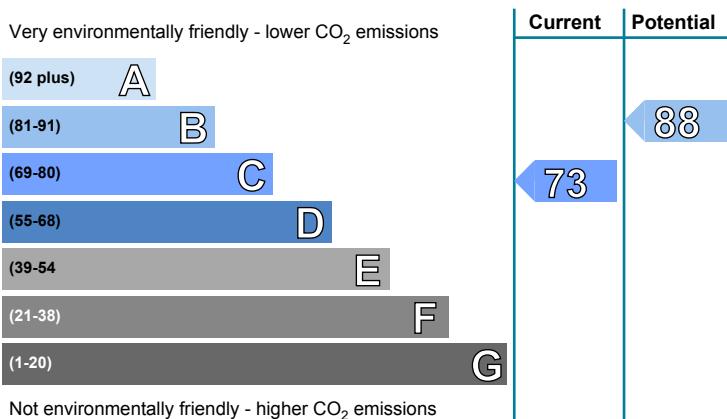
Environmental Impact (CO₂) Rating

This graph shows the effect of your home on the environment in terms of carbon dioxide (CO₂) emissions. The higher the rating, the less impact it has on the environment.

Your current rating is **band C (73)**. The average rating for EPCs in Scotland is **band D (59)**.

The potential rating shows the effect of undertaking all of the improvement measures listed within your recommendations report.
