YOUR ONESURVEY
HOME REPORT

18 Robertson Square
Wick
KW1 5NF

SINGLE SURVEY

A report on the condition of the property, with categories being rated from 1 to 3.

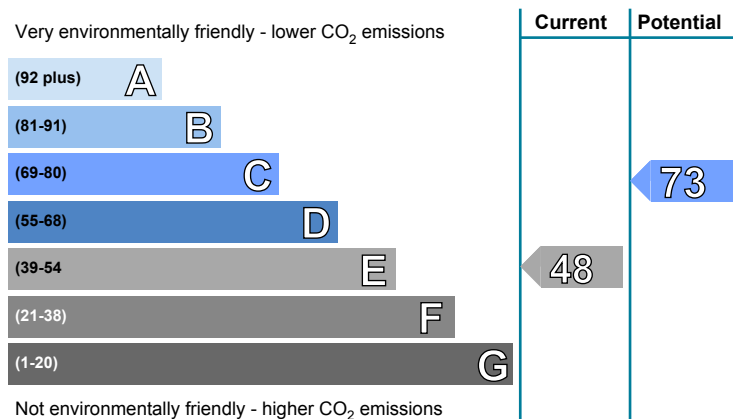
Environmental Impact (CO₂) Rating

This graph shows the effect of your home on the environment in terms of carbon dioxide (CO₂) emissions. The higher the rating, the less impact it has on the environment.
