Energy Performance Certificate

8 TERRACE STREET, EMBO, DORNOCH, IV25 3PX

Dwelling type: End-terrace house
Date of assessment: 12 February 2024
Date of certificate: 12 February 2024
Total floor area: 138 m²
Primary Energy Indicator: 233 kWh/m²/year

Reference number: 4314-8922-7000-0732-2292
Type of assessment: RdSAP, existing dwelling
Approved Organisation: ECMK
Main heating and fuel: Boiler and radiators, oil

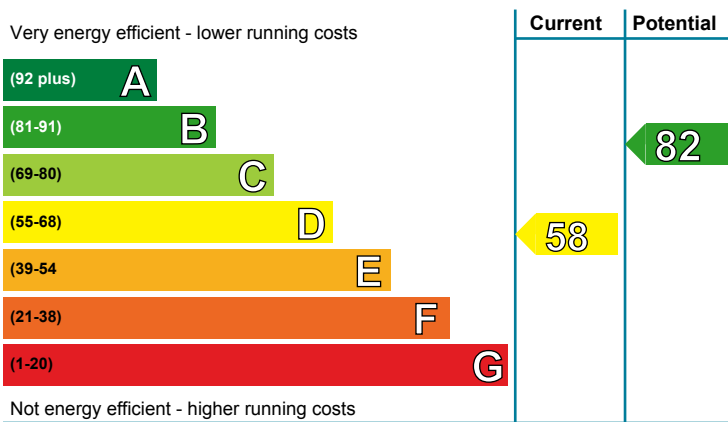
Energy Efficiency Rating

This graph shows the current efficiency of your home, taking into account both energy efficiency and fuel costs. The higher this rating, the lower your fuel bills are likely to be.

Your current rating is **band D (58)**. The average rating for EPCs in Scotland is **band D (61)**.

The potential rating shows the effect of undertaking all of the improvement measures listed within your recommendations report.

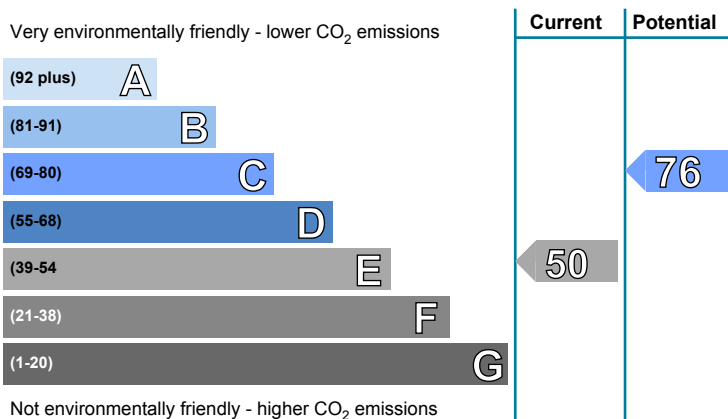
Environmental Impact (CO₂) Rating

This graph shows the effect of your home on the environment in terms of carbon dioxide (CO₂) emissions. The higher the rating, the less impact it has on the environment.

Your current rating is **band E (50)**. The average rating for EPCs in Scotland is **band D (59)**.

The potential rating shows the effect of undertaking all of the improvement measures listed within your recommendations report.

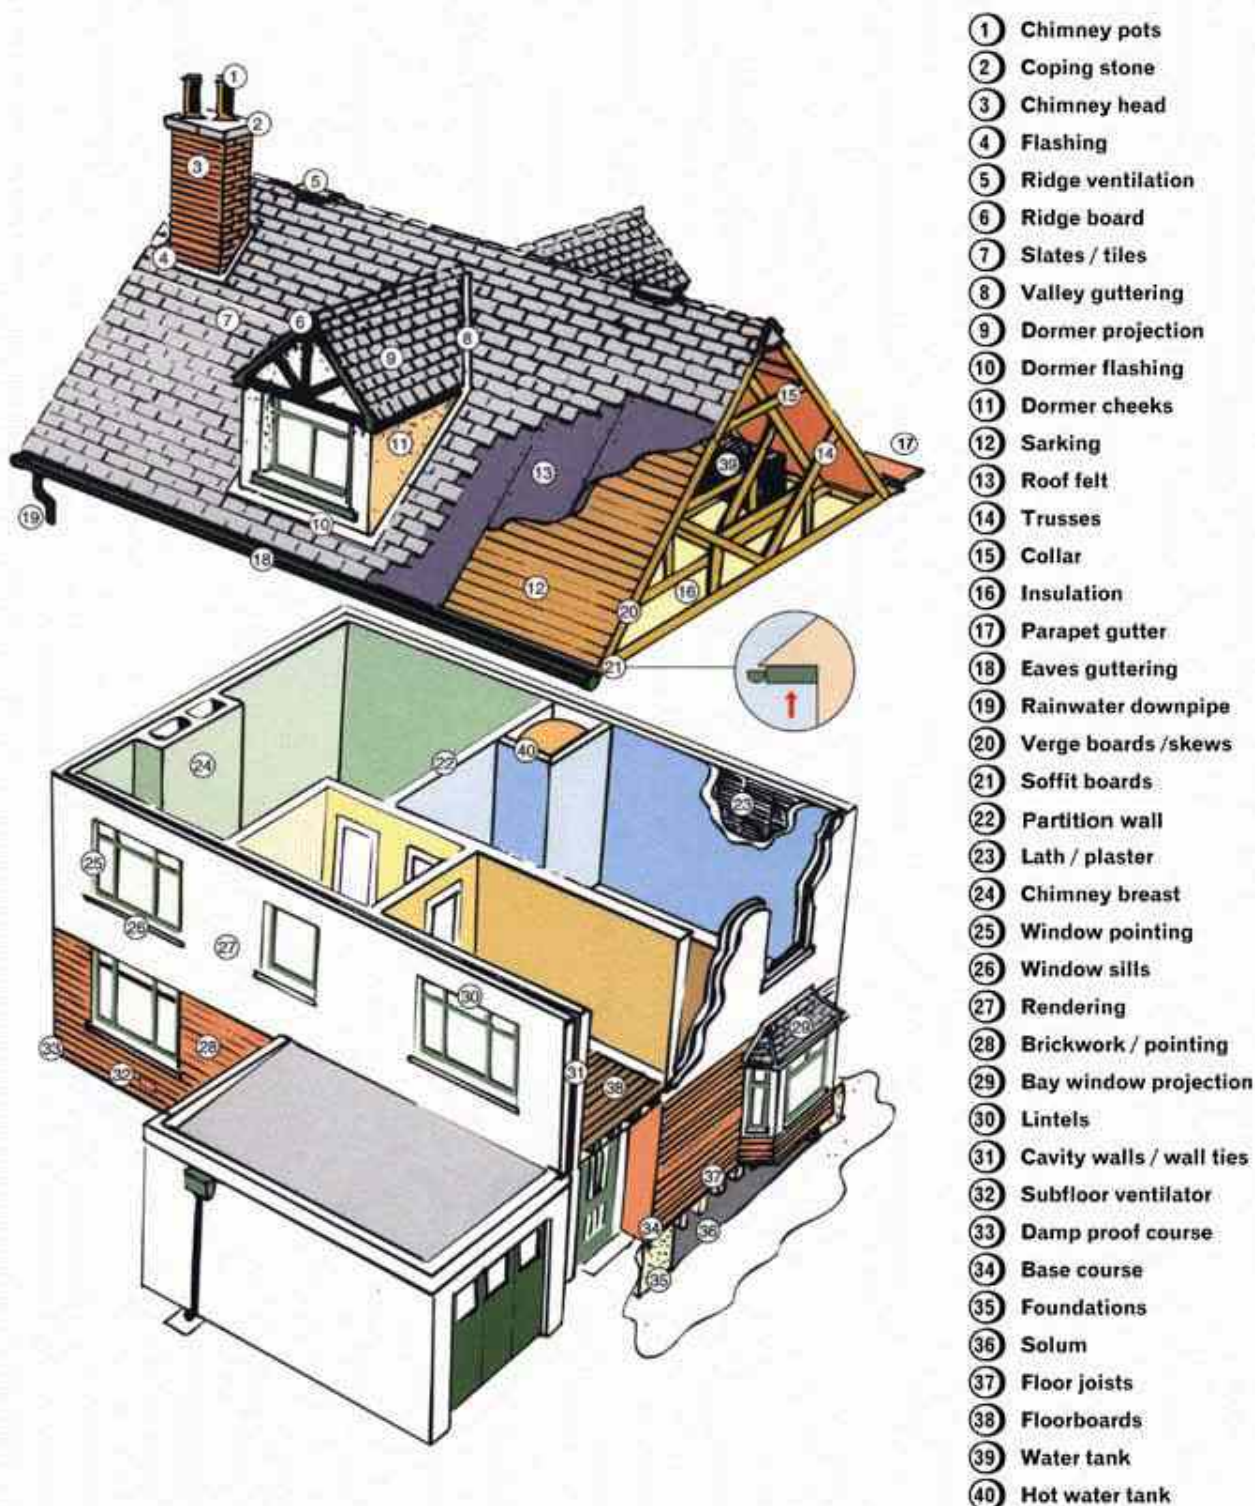
Sectional Diagram showing elements of a typical house

Reference may be made in this report to some or all of the above component parts of the property. This diagram may assist you in locating and understanding these items.
