# Home Report

Skiachbank Evanton Dingwall IV16 9UU

Date of Valuation: 03/04/2025

# Single Survey

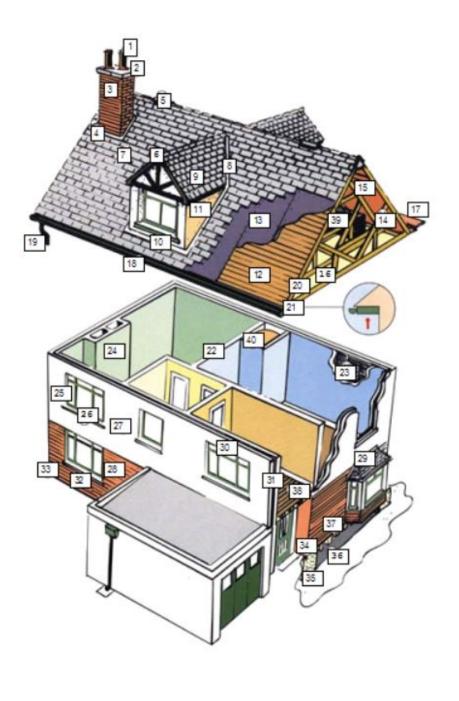
# Sectional diagram showing elements of a typical house

Chimney pots 1 Coping stone 2 3 Chimney head Flashing 4 Ridge ventilation 5 Ridge board 6 Slates / tiles 7 Valley guttering 8 9 Dormer projection Dormer flashing 10 Dormer cheeks 11 12 Sarking 13 Roof felt Trusses 14 Collar 15 Insulation 16 Parapet gutter 17 18 Eaves guttering Rainwater downpipe 19 20 Verge boards / skews 21 Soffit boards Partition wall 22 23 Lath / plaster 24 Chimney breast Window pointing 25 Window sills 26 Rendering 27 Brickwork / pointing 28 Bay window projection 29 Lintels 30 Cavity walls / wall ties 31 Subfloor ventilator 32 33 Damp proof course Base course 34 Foundations 35 Solum 36 Floor joists 37 Floorboards 38 Water tank 39 Hot water tank 40

Reference may be made in this report to some or all of the above component parts of the property. This diagram may assist you in locating and understanding these items.

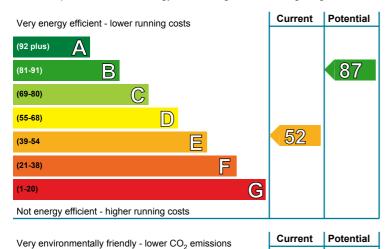
### **Energy Efficiency Rating**

This graph shows the current efficiency of your home, taking into account both energy efficiency and fuel costs. The higher this rating, the lower your fuel bills are likely to be.
