River View,
Glengolly,
Thurso,
KW14 7XD

Home Report

Single Survey

Property Address	River View, Glengolly, Thurso, KW14 7XD
Reference	1151252
Customer Name	Mary Paterson Executry
Date of Inspection	29th July 2025
Surveyor's name, qualifications and office	Simone Coles DM Hall LLP Chartered Surveyors Hope House, Cradlehall Business Park, Castlehill Drive Cradlehall Inverness IV2 5GH Tel: 01463 241077 email: invernessresidential@dmhall.co.uk
Prepared By	DM Hall LLP

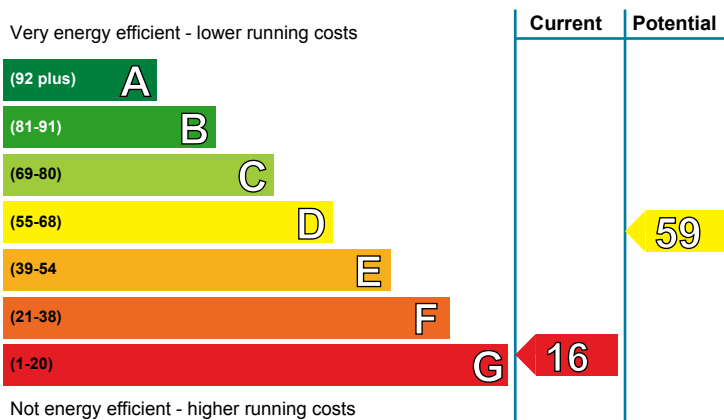
Energy Efficiency Rating

This graph shows the current efficiency of your home, taking into account both energy efficiency and fuel costs. The higher this rating, the lower your fuel bills are likely to be.

The potential rating shows the effect of undertaking all of the improvement measures listed within your recommendations report.

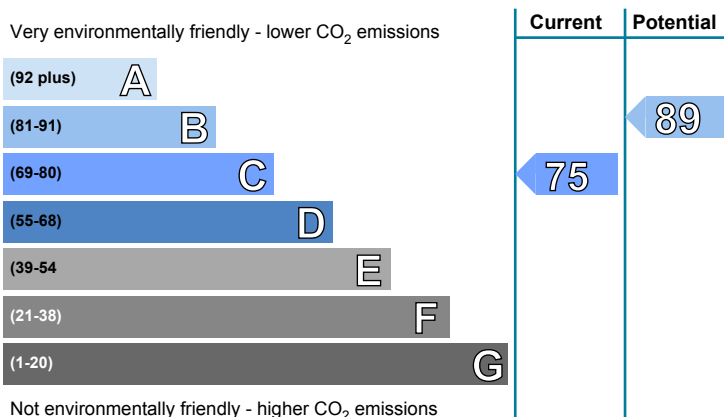
Environmental Impact (CO₂) Rating

This graph shows the effect of your home on the environment in terms of carbon dioxide (CO₂) emissions. The higher the rating, the less impact it has on the environment.
