### **Energy Performance Certificate (EPC)**

#### 14 MAIN STREET, BALINTORE, TAIN, IV20 1UE

# Single Survey

Property Address	14 Main Street Balintore Tain IV20 1UE	
Customer	Ms Lisa Clothier	
Date of Inspection	01/12/2025	
Prepared by	Jennifer Swanson Walker Fraser Steele

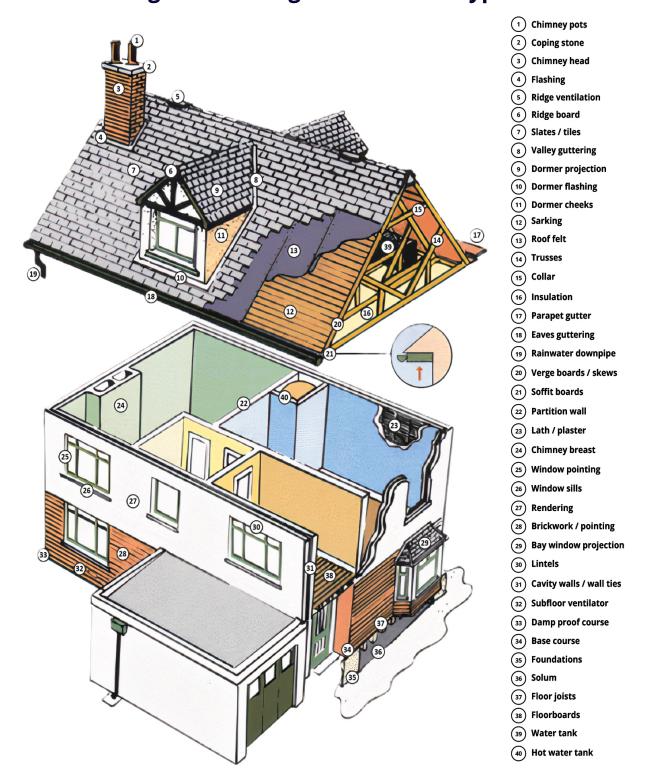
### Sectional Diagram showing elements of a typical house

Reference may be made in this report to some or all of the above component parts of the property. This diagram may assist you in locating and understanding these items.
