YOUR ONE SURVEY
HOME REPORT

146 Hazel Avenue
Culloden, Inverness
IV2 7WS

SINGLE SURVEY

Single Survey

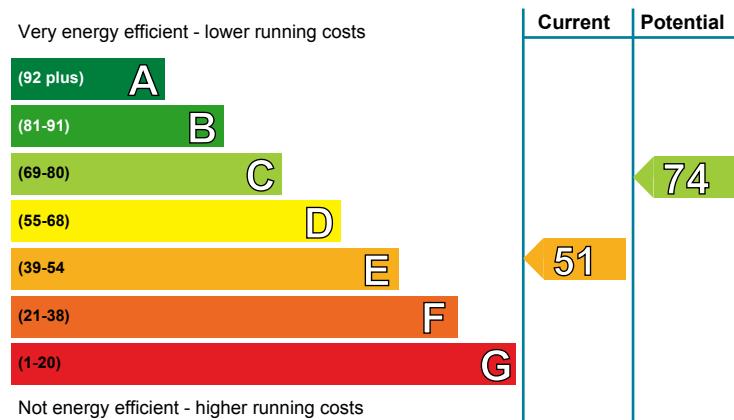
Energy Efficiency Rating

This graph shows the current efficiency of your home, taking into account both energy efficiency and fuel costs. The higher this rating, the lower your fuel bills are likely to be.

Your current rating is **band E (51)**. The average rating for EPCs in Scotland is **band D (61)**.

The potential rating shows the effect of undertaking all of the improvement measures listed within your recommendations report.

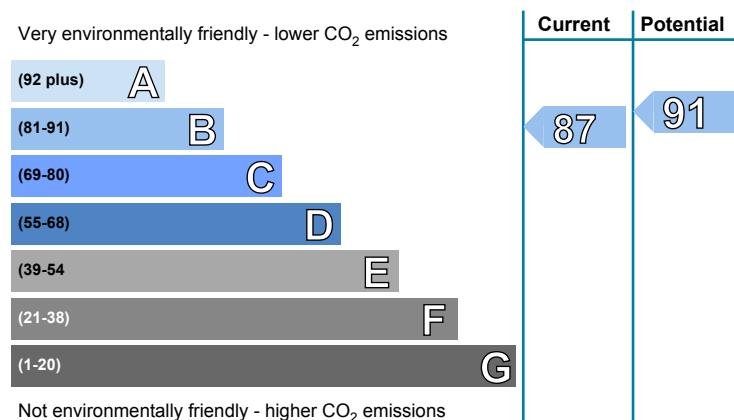
Environmental Impact (CO₂) Rating

This graph shows the effect of your home on the environment in terms of carbon dioxide (CO₂) emissions. The higher the rating, the less impact it has on the environment.
