YOUR ONESURVEY
HOME REPORT

15 Birchview Court
Inshes
Inverness
IV2 5WA

SINGLE SURVEY

Single Survey

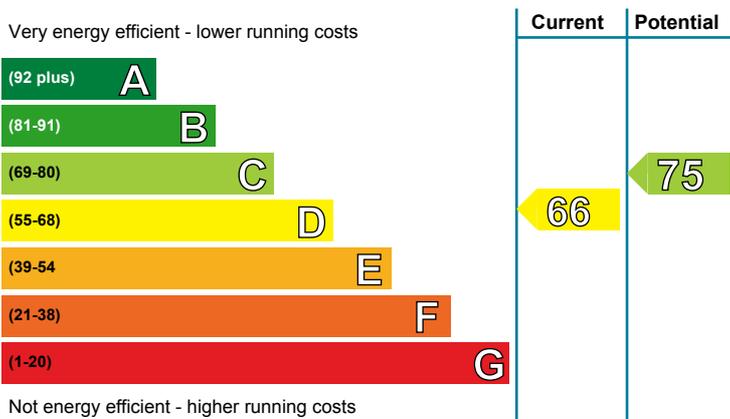
Energy Efficiency Rating

This graph shows the current efficiency of your home, taking into account both energy efficiency and fuel costs. The higher this rating, the lower your fuel bills are likely to be.

Your current rating is **band D (66)**. The average rating for EPCs in Scotland is **band D (61)**.

The potential rating shows the effect of undertaking all of the improvement measures listed within your recommendations report.

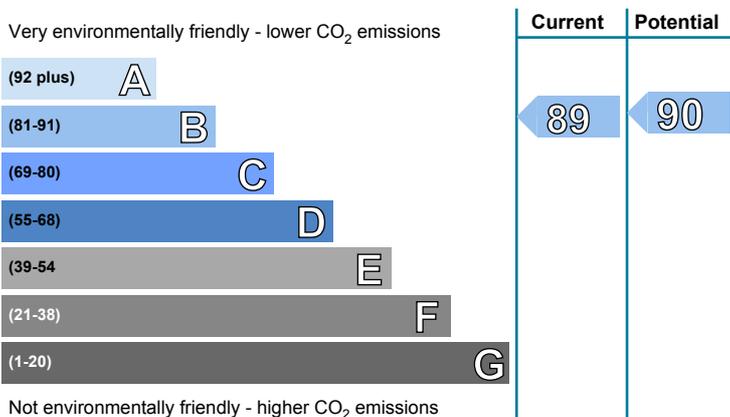
Environmental Impact (CO₂) Rating

This graph shows the effect of your home on the environment in terms of carbon dioxide (CO₂) emissions. The higher the rating, the less impact it has on the environment.
