# Home Report

23 Oakleigh Road  
North Kessock Inverness IV1 3XW

# Single Survey

| Property Address | 23 Oakleigh Road<br>Inverness<br>IV1 3XW |

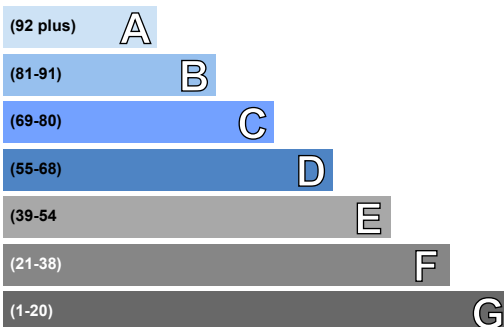
The potential rating shows the effect of undertaking all of the improvement measures listed within your recommendations report.

Very environmentally friendly - lower CO<sub>2</sub> emissions

Not environmentally friendly - higher CO<sub>2</sub> emissions

| Current | Potential |
