YOUR ONE SURVEY
HOME REPORT

6 Fraser Street
Conon Bridge
Dingwall
IV7 8BW

SINGLE SURVEY

Single Survey

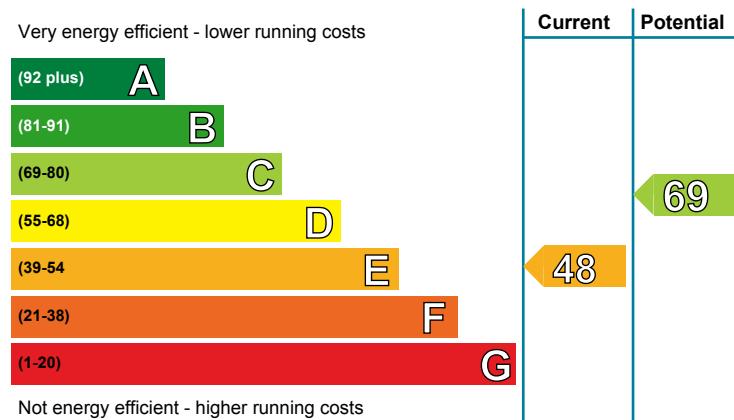
Energy Efficiency Rating

This graph shows the current efficiency of your home, taking into account both energy efficiency and fuel costs. The higher this rating, the lower your fuel bills are likely to be.

Your current rating is **band E (48)**. The average rating for EPCs in Scotland is **band D (61)**.

The potential rating shows the effect of undertaking all of the improvement measures listed within your recommendations report.

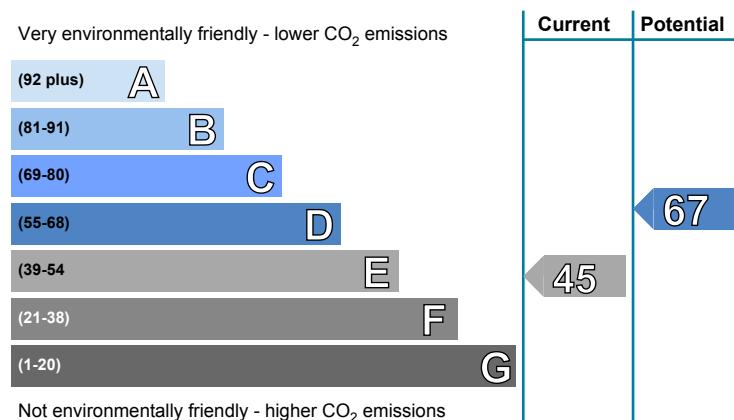
Environmental Impact (CO₂) Rating

This graph shows the effect of your home on the environment in terms of carbon dioxide (CO₂) emissions. The higher the rating, the less impact it has on the environment.
