YOUR ONESURVEY
HOME REPORT

Dunadd
Tulloch Avenue
Dingwall
IV15 9TU

SINGLE SURVEY

Customer	David Carter and Kirsty Reid
Selling address	Dunadd Tulloch Avenue Dingwall IV15 9TU
Date of Inspection	27/01/2026
Prepared by	James Burns, BSc MRICS Inverness - Allied Surveyors Scotland Ltd

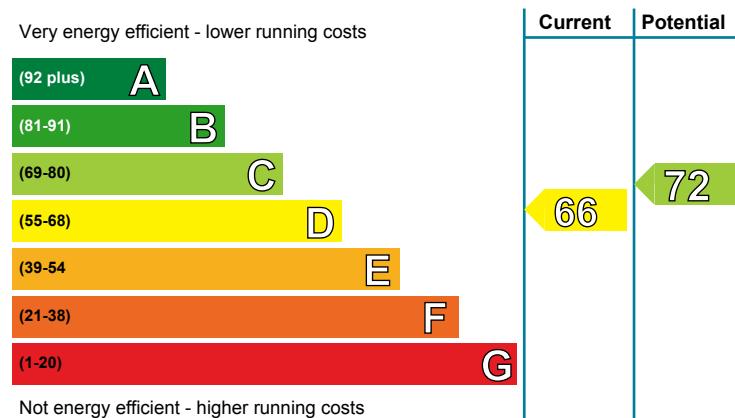
Energy Efficiency Rating

This graph shows the current efficiency of your home, taking into account both energy efficiency and fuel costs. The higher this rating, the lower your fuel bills are likely to be.

Your current rating is **band D (66)**. The average rating for EPCs in Scotland is **band D (61)**.

The potential rating shows the effect of undertaking all of the improvement measures listed within your recommendations report.

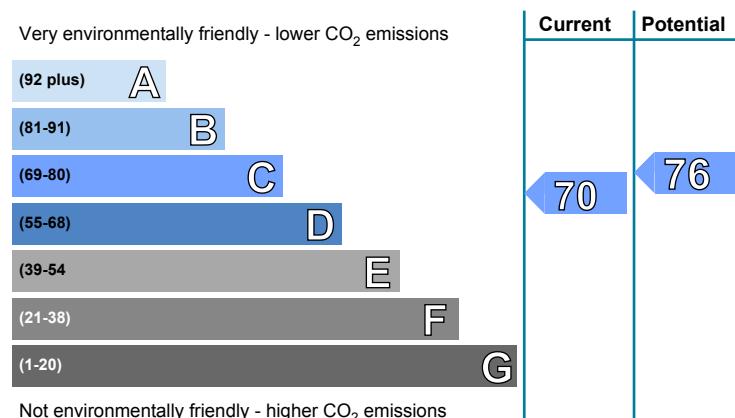
Environmental Impact (CO₂) Rating

This graph shows the effect of your home on the environment in terms of carbon dioxide (CO₂) emissions. The higher the rating, the less impact it has on the environment.
